Surveyor: Zaw La

Date Visited: 25.7.2016

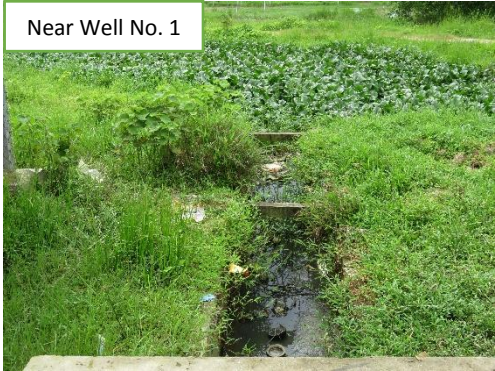
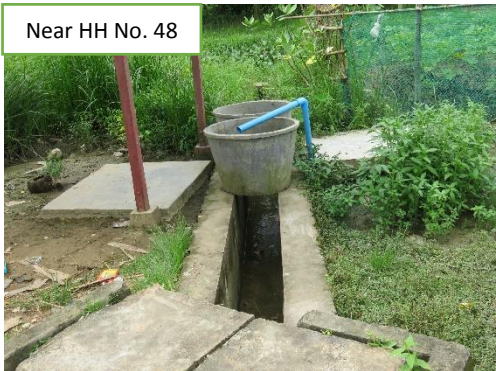
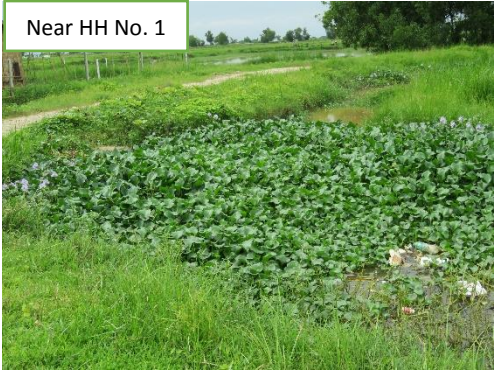
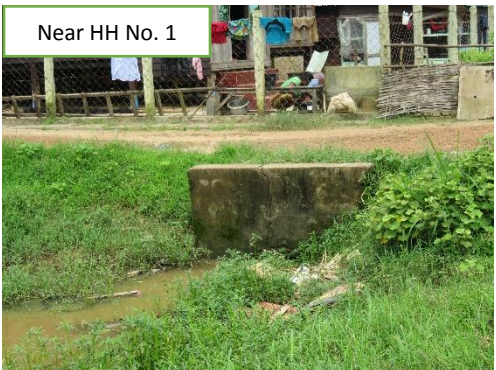
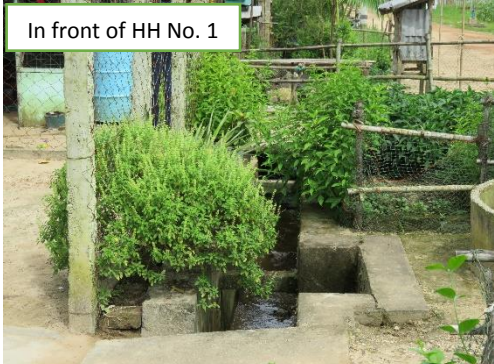
(2). <u>Drainage</u>	Improved <input type="checkbox"/> Same <input checked="" type="checkbox"/> * Worse <input type="checkbox"/> <i>*as last week</i>	<u>Description</u> There is some amount of water in the drainage canals due to the rain two days ago and some places of stream seem to be blocking at the moment. The stream along the drainage canal may need to be rehabilitated in order to improve the water-flow along the stream. <u>Photos</u> <div style="display: flex; flex-wrap: wrap;"> <div style="width: 50%; text-align: center;"> <p>Near Well No. 1</p>

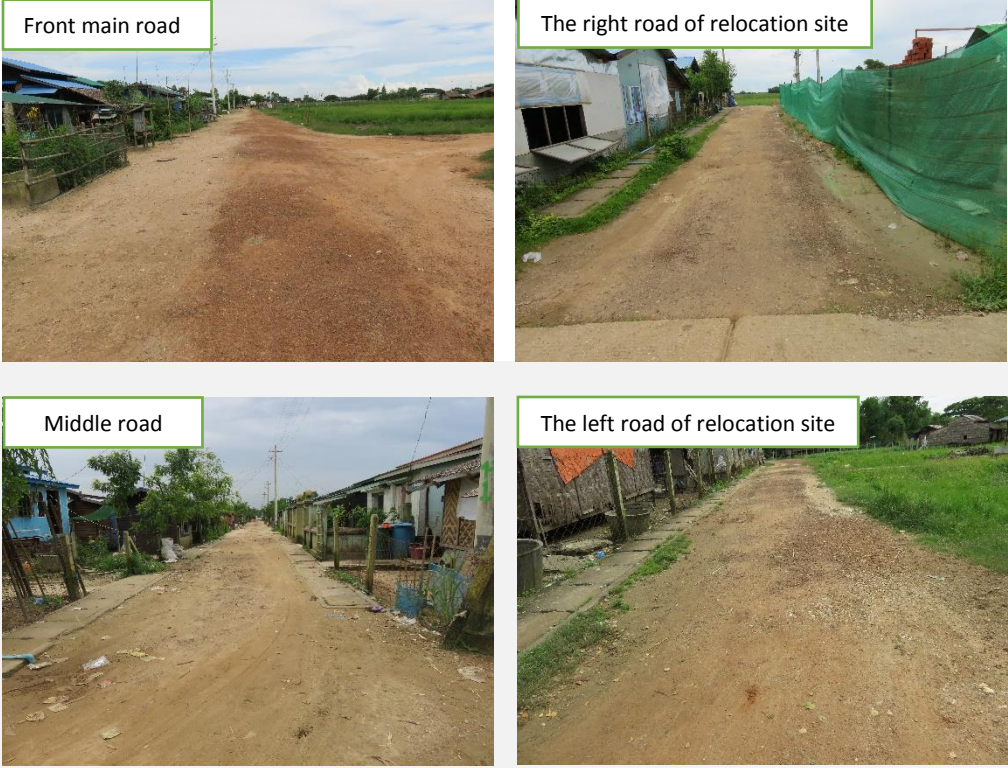
(3). Road	<p>Improved <input checked="" type="checkbox"/>*</p> <p>Same <input type="checkbox"/></p> <p>Worse <input type="checkbox"/></p> <p><i>*as last week</i></p>	<p><u>Description</u></p> <p>-The roads are being dry and no problem for walking.</p> <p><u>Photos</u></p>

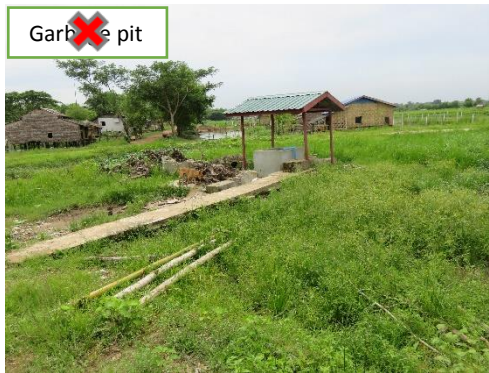
Garbage pit

(4). Garbage Condition	<p>Improved <input type="checkbox"/></p> <p>Same <input checked="" type="checkbox"/>*</p> <p>Worse <input type="checkbox"/></p>	<p><u>Description</u></p> <p>- People do not want to use garbage pit again.</p> <p>- They do not like people to take washing clothes and showering near the well and therefore garbage pit was demolished and water storage tank has been constructed instead of it.</p> <p>-Trash from all houses will be collected by garbage truck biweekly until starting of the community fund.</p> <p>-There is a small vegetable planting field at the backside of Third Row where there were many trashes before the vegetable plantation was started.</p>

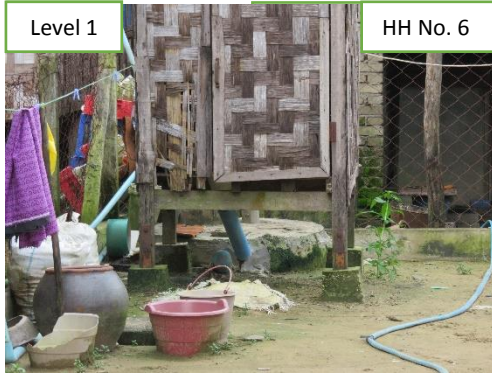
HH No. 6

-All of the fly proof toilets are used by people.
 -Almost all of the fly proof toilets made by wood or bamboo have been lifted up as shown in pictures below and are convenient to use. Some concrete toilets are still needed to be renovated. According to discussion with community people, they would like to repair the concrete toilets by themselves and requested for financial support. JET had already paid for it.

- Fly proof toilet is not needed to be repaired.
- No/rarely toilet unavailable

Level 1

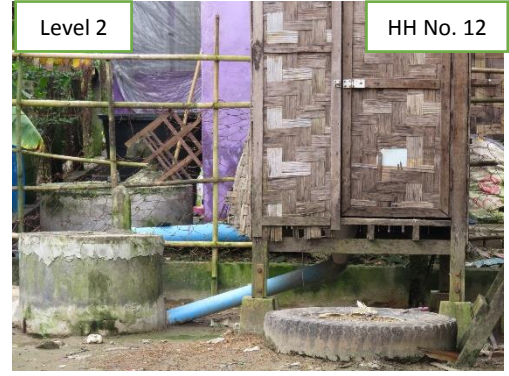
HH No. 12

- Fly proof toilet is needed to be repaired.
- Rarely toilet unavailable

Level 2

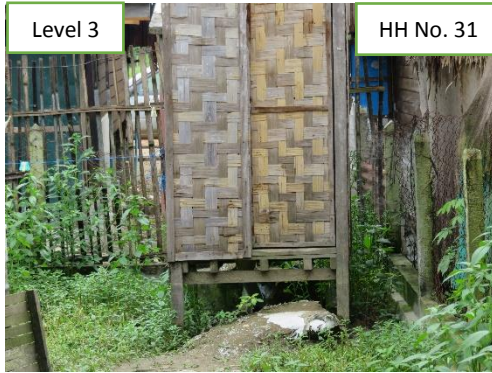
HH No. 31

- Fly proof toilet is needed to be repaired.
- Often toilet unavailable

-As the result of filling the soil and also due to the heavy rain, some toilets are inconvenience to use.

Level 3

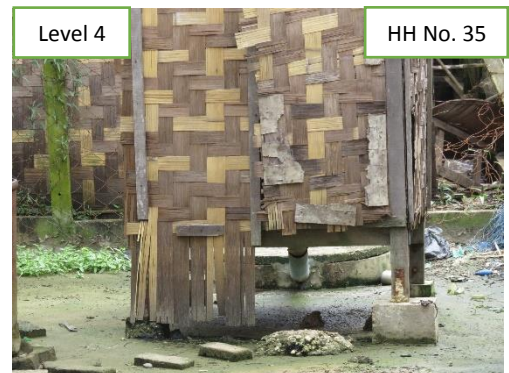
HH No. 35

- Fly proof toilet is urgently needed to be repaired.

-Often toilet unavailable

Level 4

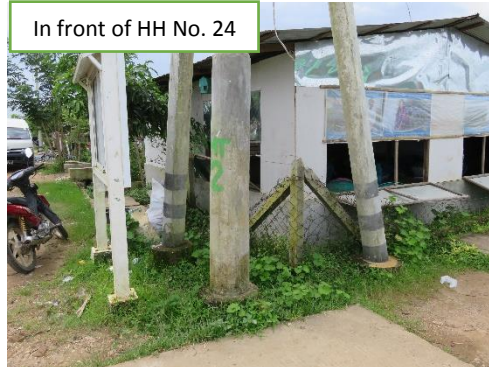
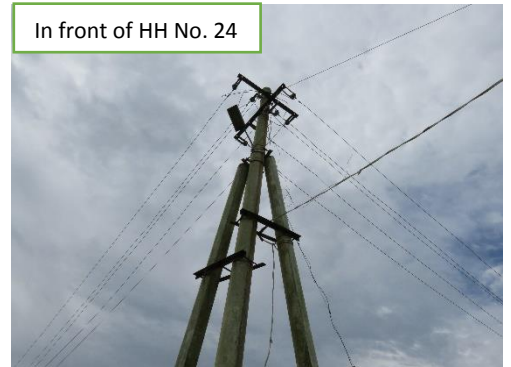
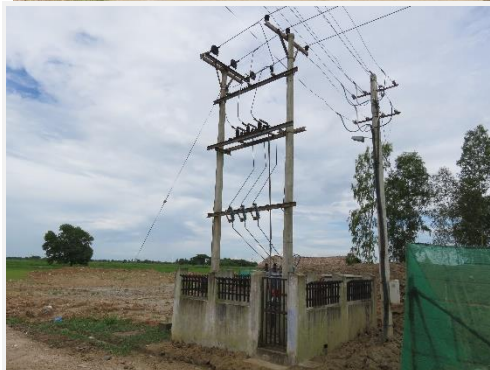
In front of HH No. 24

-Electricity comes regularly.
-Electric poles and transformer are being supported with a good foundation.
-There was a hole at an electric pole which was hit by a truck car but the electric pole was renovated.

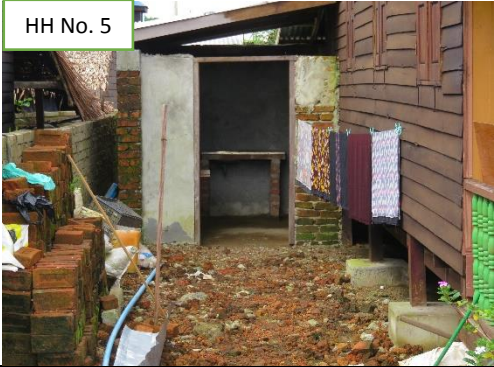
No	Item	Condition	Description and Photos																	
2	House Construction	No. of houses not completed (2)	<p><u>Description</u> -HH No.5, the construction for kitchen, toilet and water tank seems to be stopped again.</p>

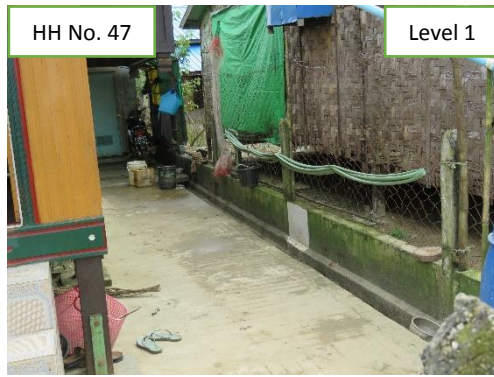
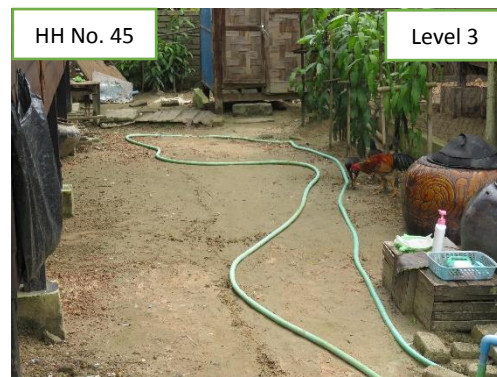
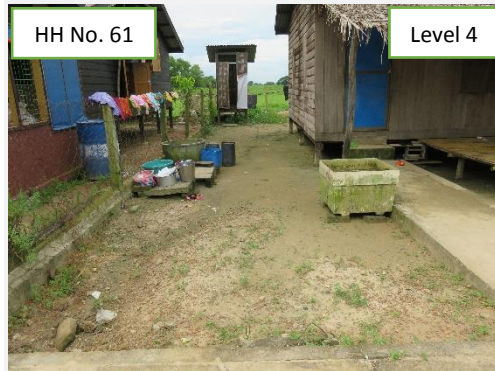
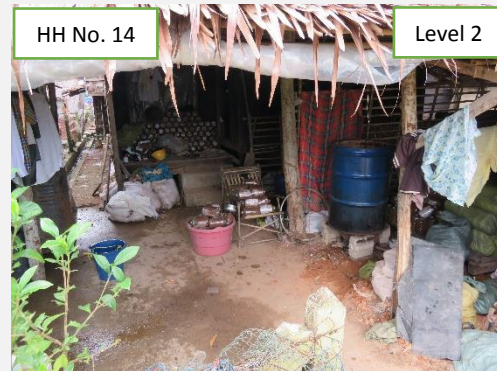
<p><Evaluation Criteria></p> <p>Level 1 -No mud and no standing water with their own drainage system in their compound</p> <p>Level 2 -No mud and no standing water in their compound</p> <p>Level 3 - Some or little mud and standing water in their compound</p> <p>Level 4 -A lot of mud and standing water in their compound</p>	Condition	No. of HHs		This week condition	Previous week condition	Level 1	63	63	Level 2	5	5	Level 3	0	0	Level 4	0	0
Condition	No. of HHs																			
	This week condition	Previous week condition																		
Level 1	63	63																		
Level 2	5	5																		
Level 3	0	0																		
Level 4	0	0

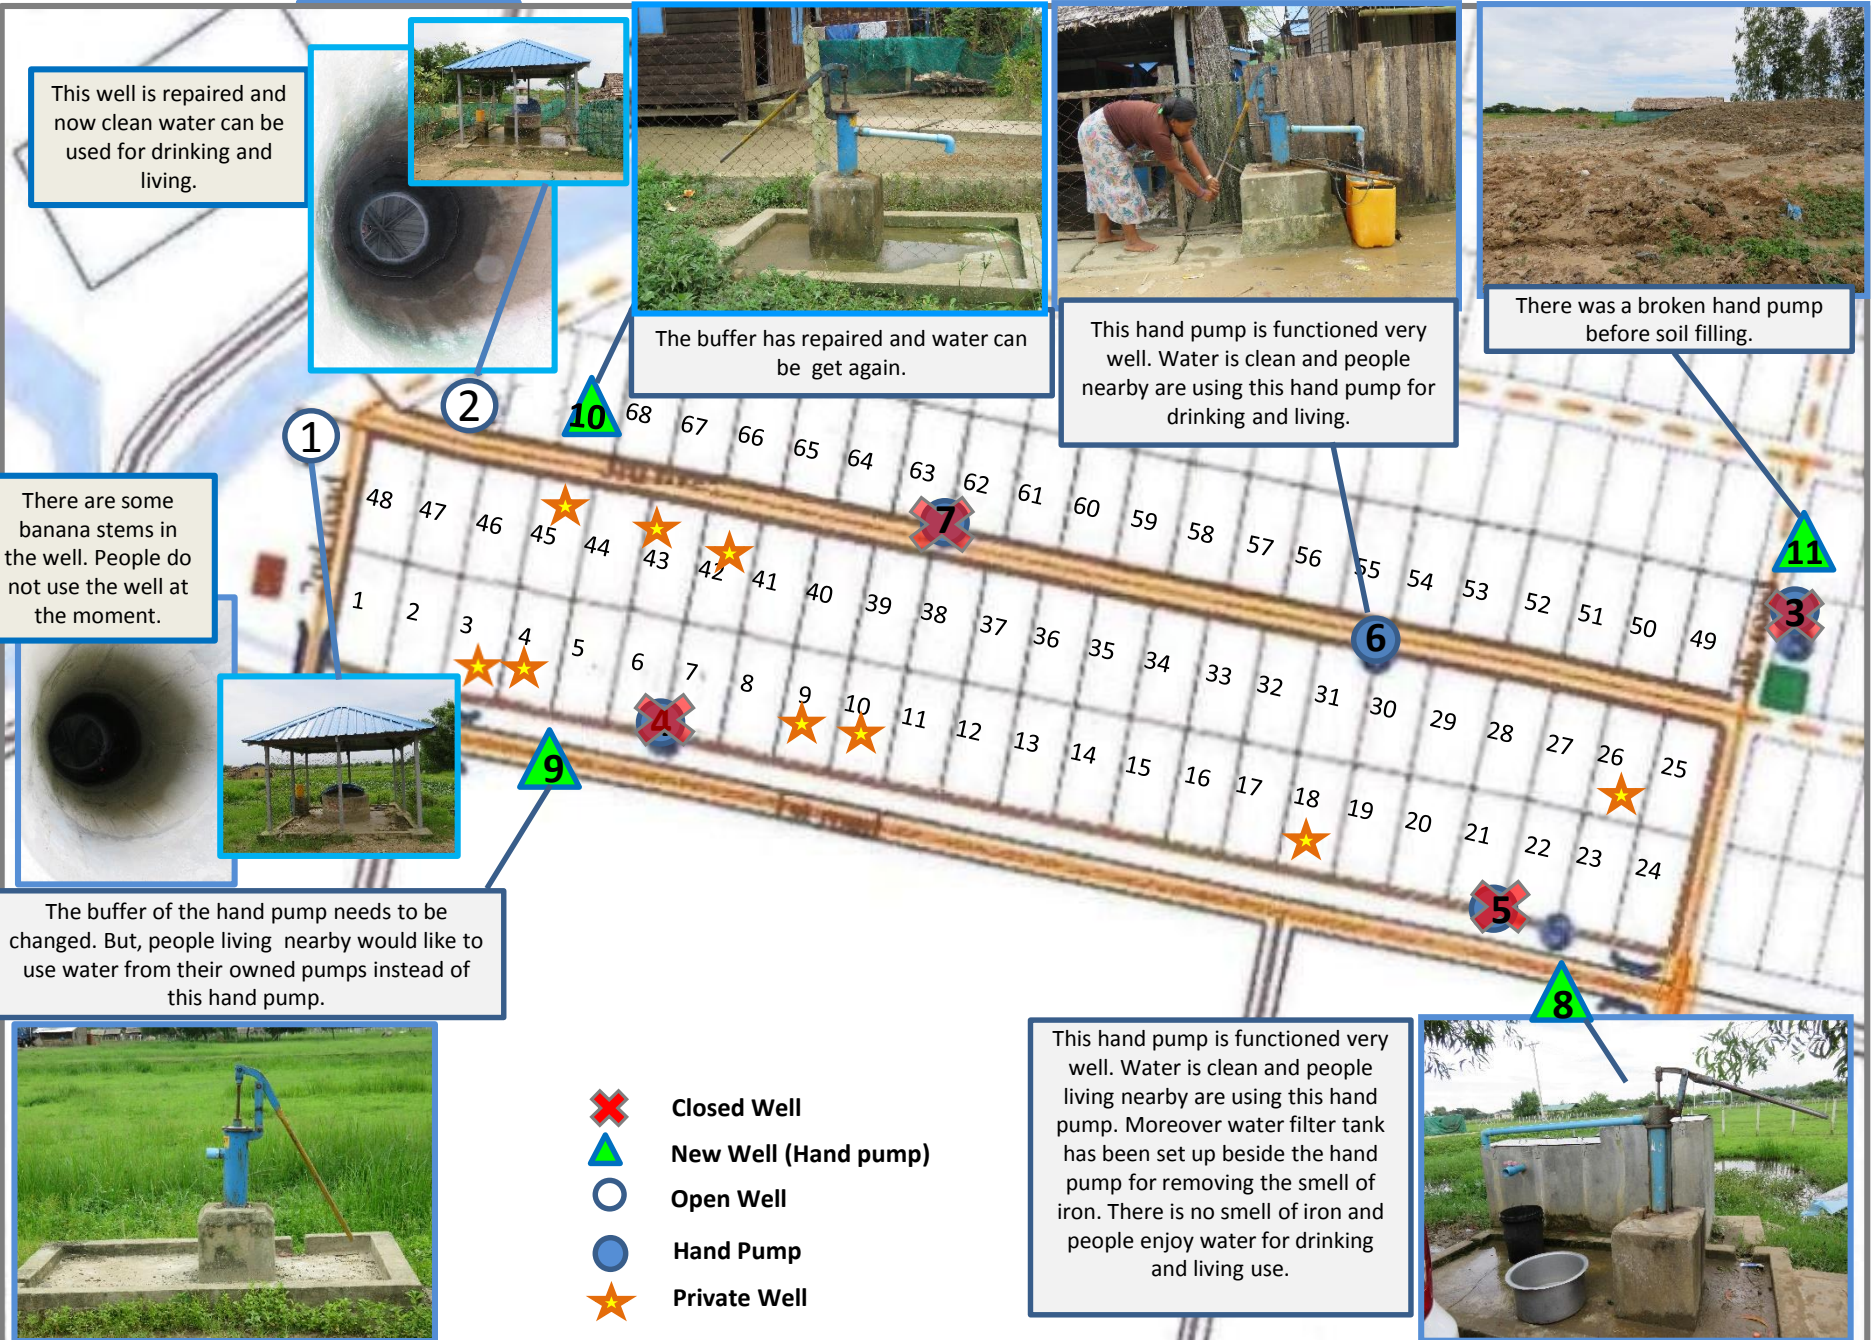
No	Item	Condition	Description and Photos
1	Condition of -		
	(1). Well	Improved <input type="checkbox"/> Same <input checked="" type="checkbox"/> * Worse <input type="checkbox"/> <i>*as last week</i>	Description & Photos: -See ANNEX.1 - Water from both of two wells is clean and can be used for drinking and living. The amount of water in both wells is also being increased during these days. There are four tube wells in the relocation site. Among them, one of the hand pump needs to be repaired, but people can get water from their own tube-wells, one open-well and the rest of two hand pumps.
