Surveyor: Zaw La
 Date Visited: 01.12.2016
 Time Visited: 15:00 to 16:00

No	Item	Condition	Description and Photos
1	Condition of -		
	(1). Well	Improved <input type="checkbox"/> Same <input checked="" type="checkbox"/> * Worse <input type="checkbox"/> <i>*as last week</i>	Description & Photos: -See ANNEX.1 - Water from only one open-well is clean and can be used for drinking and living but the other open-well need to be cleaned as there is some trashes in the well. There are four tube wells in the relocation site. Among them, two of the hand pumps need to be repaired, but people can get water from their own tube-wells, one open-well and the rest of one hand pump.

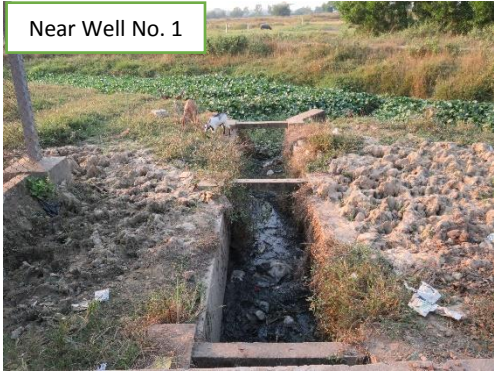
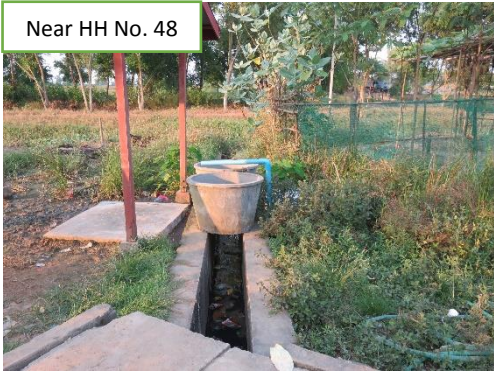
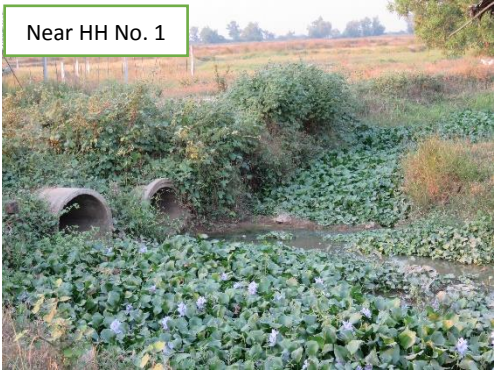
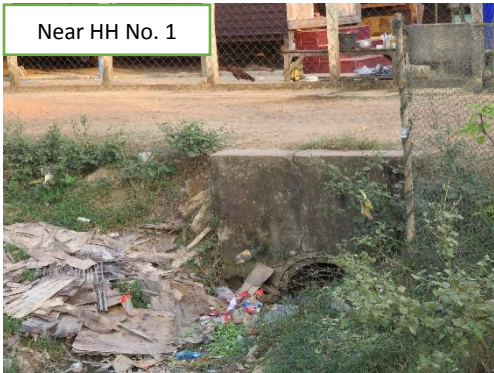
(2). Drainage	Improved <input type="checkbox"/> Same <input checked="" type="checkbox"/> * Worse <input type="checkbox"/> <i>*as last week</i>	<u>Description</u> There is some amount of water in the drainage canals and some places of stream seem to be blocking at the moment. The stream along the drainage canal may need to be rehabilitated in order to improve the water-flow along the stream. <u>Photos</u> <div style="display: flex; flex-wrap: wrap;"> <div style="width: 50%; text-align: center;">

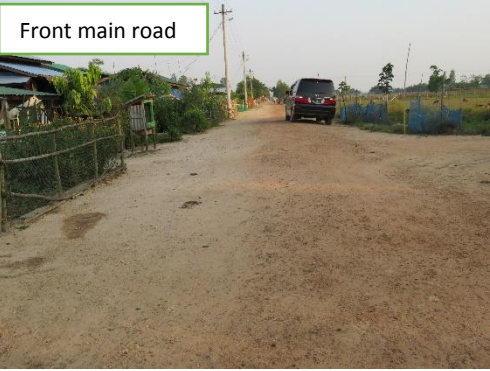
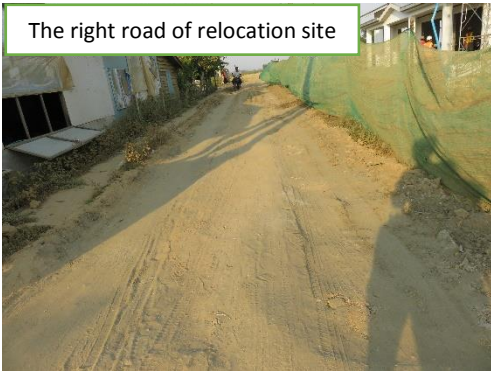
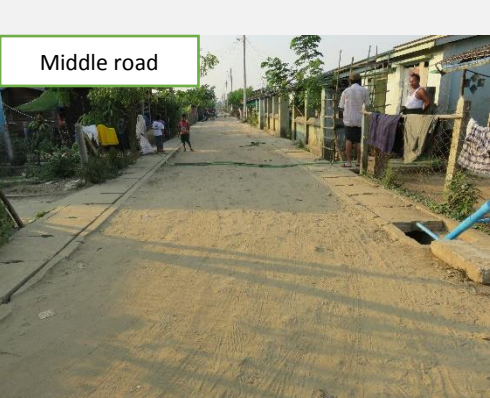
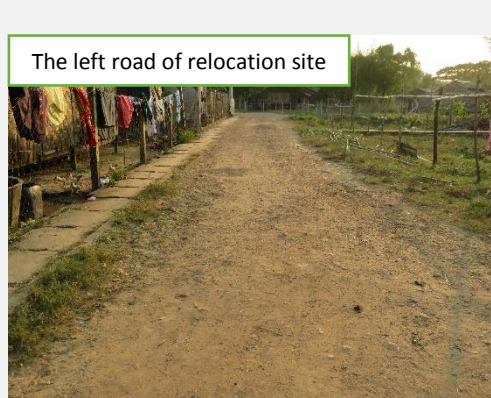
(3). Road	<p>Improved <input checked="" type="checkbox"/>*</p> <p>Same <input type="checkbox"/></p> <p>Worse <input type="checkbox"/></p> <p><i>*as last week</i></p>	<p><u>Description</u></p> <p>-The roads are dry and no problem for walking.</p> <p><u>Photos</u></p>

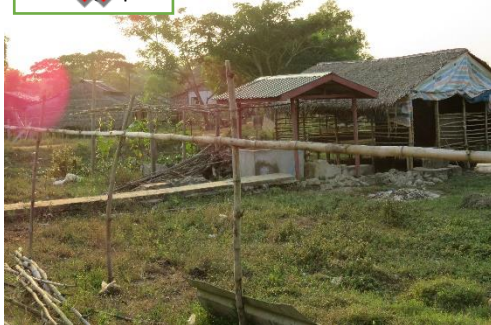
Garbage pit

(4). Garbage Condition	<p>Improved <input type="checkbox"/></p> <p>Same <input checked="" type="checkbox"/>*</p> <p>Worse <input type="checkbox"/></p>	<p><u>Description</u></p>	<p>- People do not want to use garbage pit again.</p> <p>- They do not like people to take washing clothes and showering near the well and therefore garbage pit was demolished and water storage tank has been constructed instead of it.</p> <p>-Trash from all houses will be collected by garbage truck biweekly until starting of the community fund.</p> <p>-There was a small seasonal vegetable planting field at the backside of Third Row. Now the season is over and there will be a small plantation field in next season.</p>

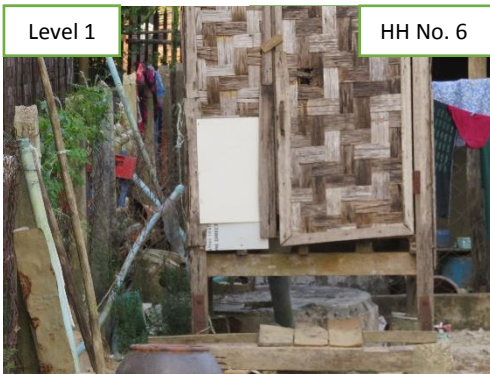
HH No. 6

- Fly proof toilet is not needed to be repaired.
- No/rarely toilet unavailable

Level 1

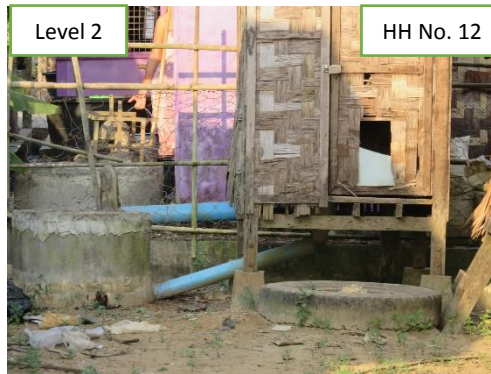
HH No. 12

- Fly proof toilet is needed to be repaired.
- Rarely toilet unavailable

Level 2

-All of the fly proof toilets are used by people.
-Almost all of the fly proof toilets made by wood or bamboo have been lifted up as shown in pictures below and are convenient to use. Some concrete toilets are still needed to be renovated. According to discussion with community people, they would like to repair the concrete toilets by themselves and requested for financial support. JET had already paid for it.

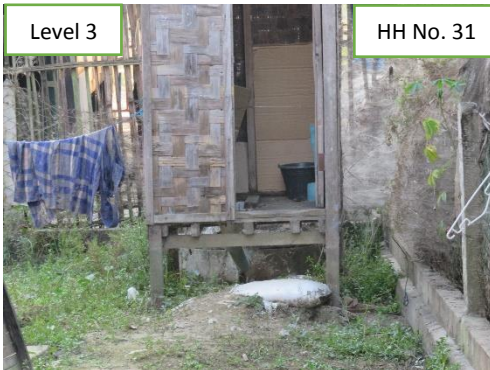
HH No. 31

- Fly proof toilet is needed to be repaired.
- Often toilet unavailable

-As the result of filling the soil and also due to the heavy rain, some toilets are inconvenience to use.

Level 3

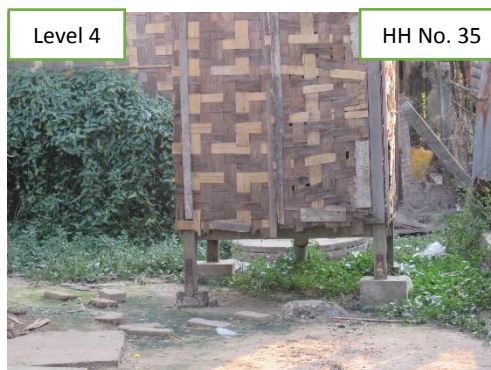
HH No. 35

- Fly proof toilet is urgently needed to be repaired.

-Often toilet unavailable

Level 4

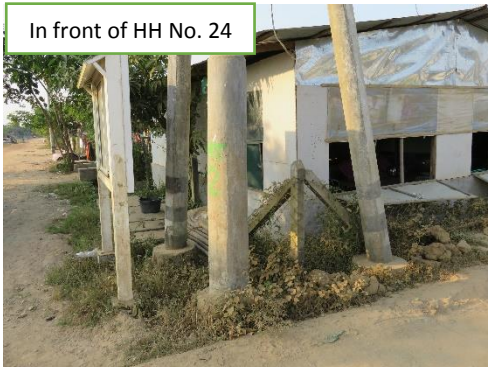
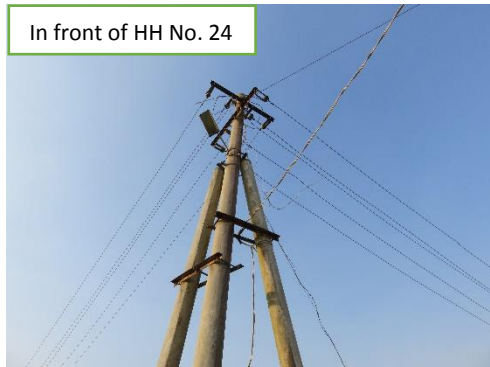
In front of HH No. 24

-Electricity comes regularly.
-Electric poles and transformer are being supported with a good foundation.
-There was a hole at an electric pole which was hit by a truck car but the electric pole was renovated.

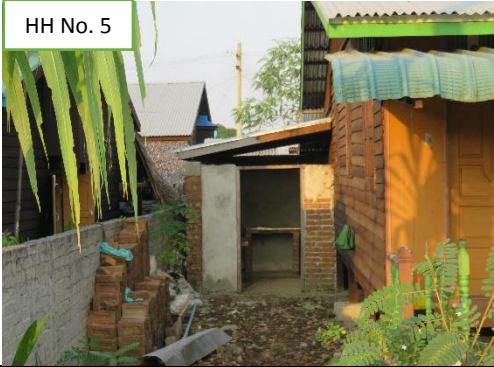
No	Item	Condition	Description and Photos																	
2	House Construction	No. of houses not completed (2)	<p><u>Description</u> -HH No.5, the construction for kitchen, toilet and water tank seems to be stopped again.</p>

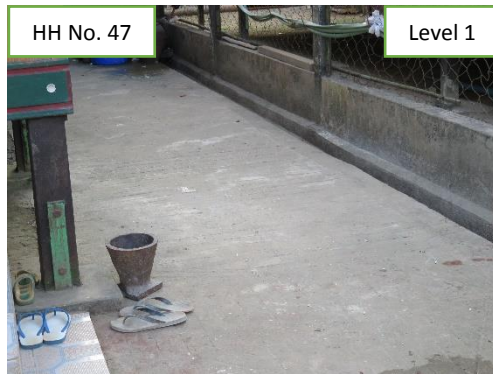
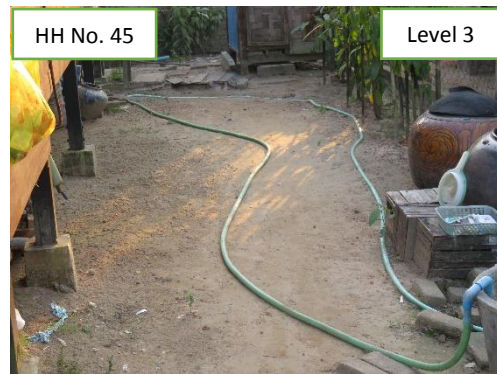
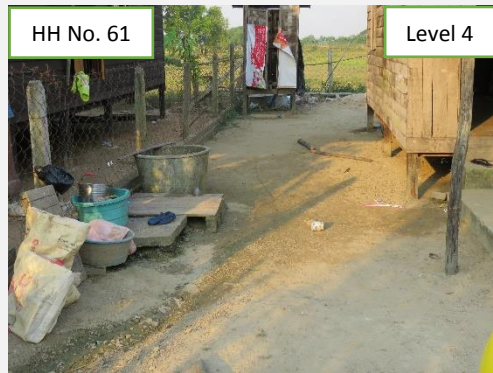
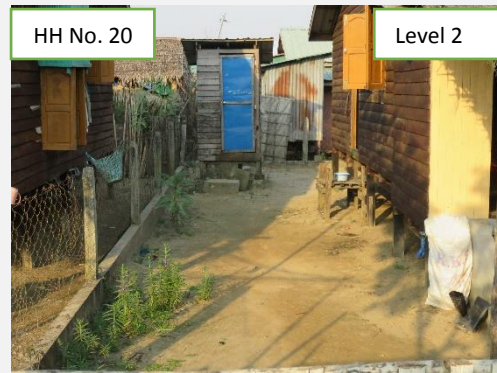
<p><Evaluation Criteria></p> <p>Level 1 -No mud and no standing water with their own drainage system in their compound</p> <p>Level 2 -No mud and no standing water in their compound</p> <p>Level 3 - Some or little mud and standing water in their compound</p> <p>Level 4 -A lot of mud and standing water in their compound</p>	Condition	No. of HHs		This week condition	Previous week condition	Level 1	63	63	Level 2	5	5	Level 3	0	0	Level 4	0	0
Condition	No. of HHs																			
	This week condition	Previous week condition																		
Level 1	63	63																		
Level 2	5	5																		
Level 3	0	0																		
Level 4	0	0
