Surveyor: Zaw La  
 Date Visited: 8.12.2015  
 Time Visited: 15:45 to 16:45

No	Item	Condition	Description and Photos
1	<b>Condition of -</b>		
	(1). Well	Improved <input type="checkbox"/> Same <input checked="" type="checkbox"/> * Worse <input type="checkbox"/>  *as last week	Description & Photos: -See ANNEX.1 - Although both of the two open wells are dirty, it seems that muddy water under the ground is passing through the crack at the wall of the well. Therefore both wells have been repairing now. One of the hand pump need to be repaired, but people get water from their own tube-well.

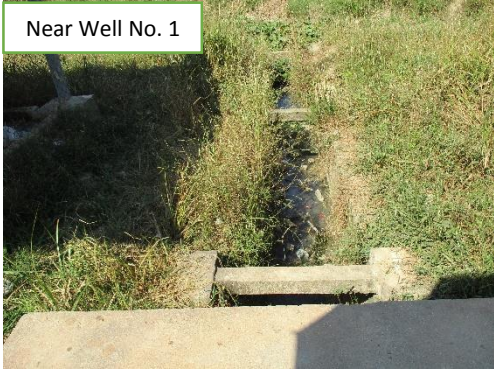
(2). Drainage	Improved <input type="checkbox"/> Same <input checked="" type="checkbox"/> * Worse <input type="checkbox"/> *as last week	<u>Description</u> -Water level in the drainage canals are decreased than last week because there was no rain. The stream along the drainage canal may need to be rehabilitated in coming summer period in order to improve the water-flow along the stream.  <u>Photos</u> <div style="display: flex; flex-wrap: wrap;"> <div style="width: 50%; text-align: center;"> <p>Near Well No. 1</p>

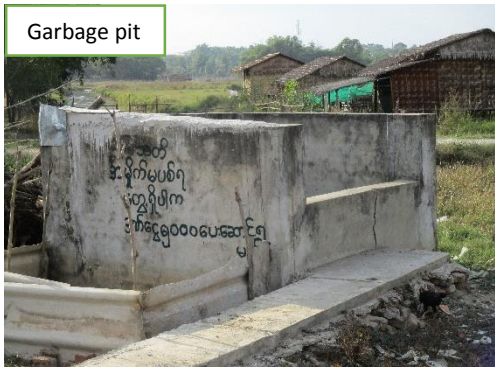
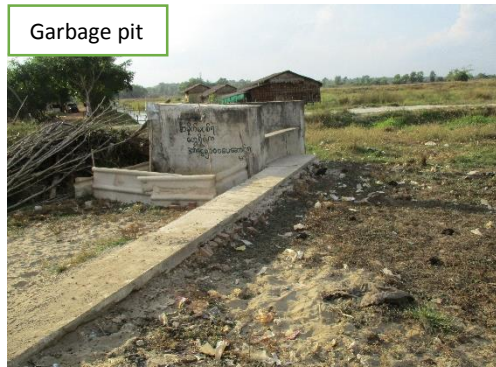
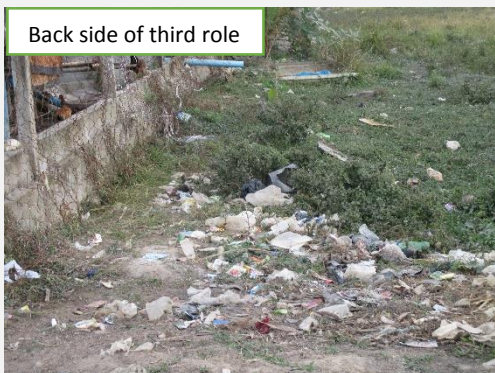
<p>In front of HH No. 1</p>  
(3). Road	<p>Improved <input checked="" type="checkbox"/>*</p> <p>Same <input type="checkbox"/></p> <p>Worse <input type="checkbox"/></p> <p><i>*as last week</i></p>	<p><u>Description</u></p> <p>-The roads are being dry and no problem for walking.</p> <p><u>Photos</u></p>	<p>Front main road</p>   <p>The right road of relocation site</p>   <p>Middle road</p>   <p>The left road of relocation site</p>

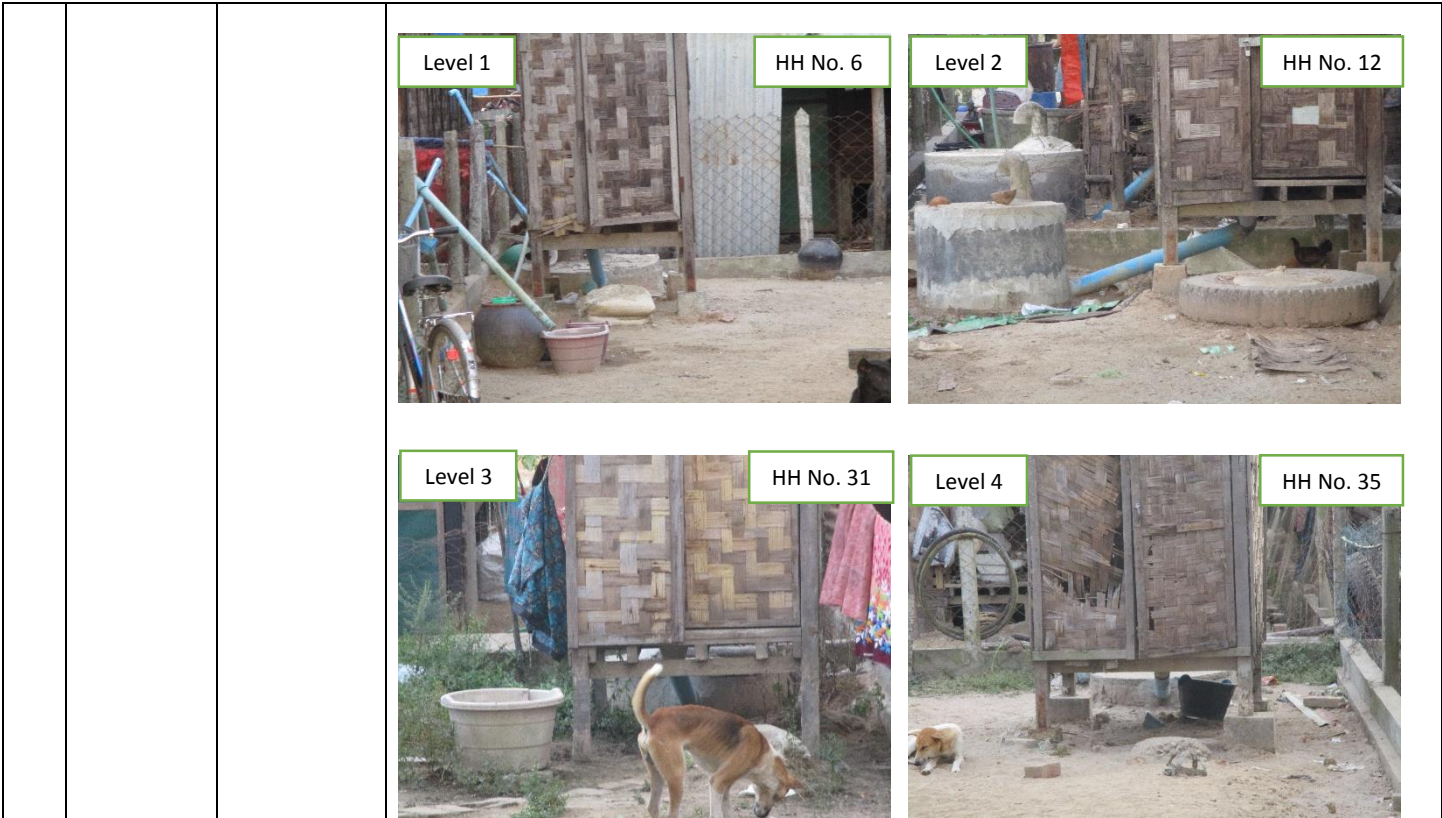
-All of fly proof toilets are used by people.  
-Almost all of fly proof toilets made by wood or bamboo have been lifted up as shown in pictures below and are convenient to use. Some concrete toilets are still need to be renovated. According to discussion with community people, the concrete toilets are would like to be repaired by themselves and they requested for financial support. JET had already paid for it.

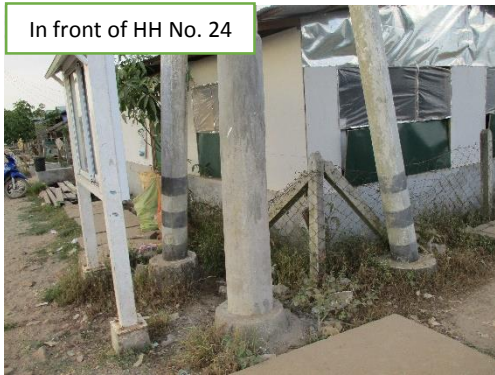
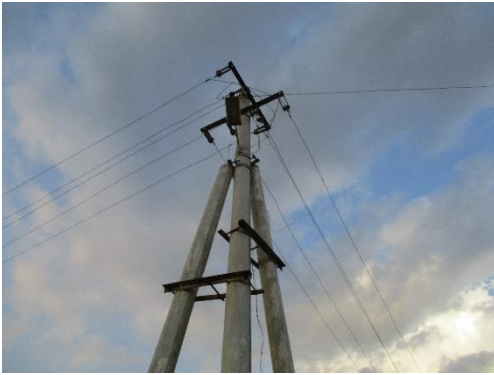
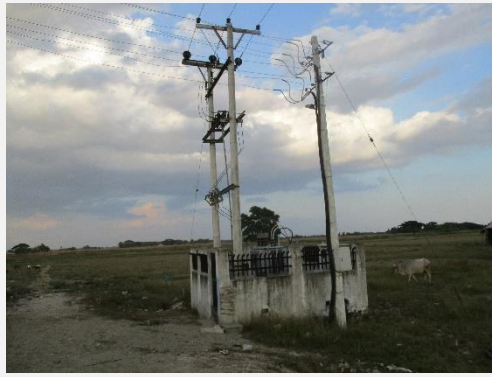
- Electricity comes regularly.
- Electric poles and transformer are being supported with a good foundation.
- There was a hole at an electric pole which was hit by a truck car, but the electric pole was renovated.

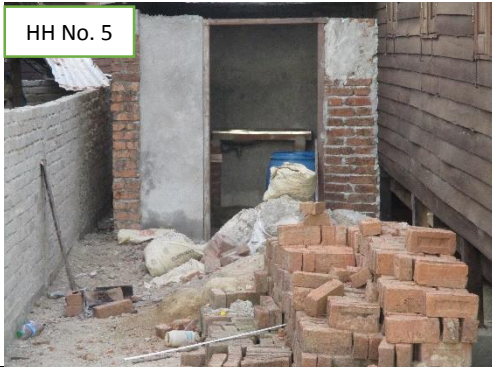
No	Item	Condition	Description and Photos
2	House Construction	No. of houses not completed (2)	<p><u>Description</u> -HH No.5, the construction for kitchen, toilet and water tank seems to be stopped again.</p>

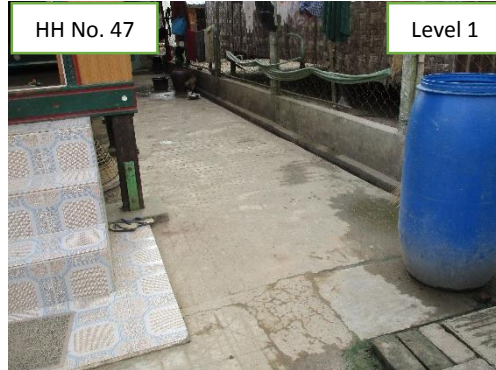
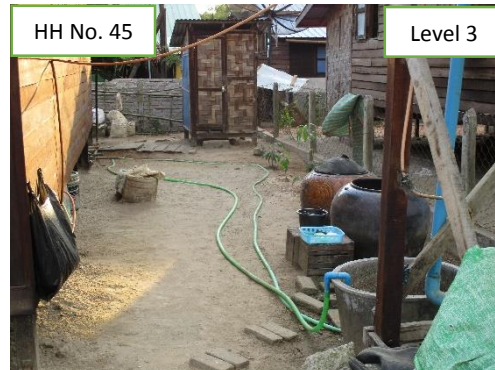
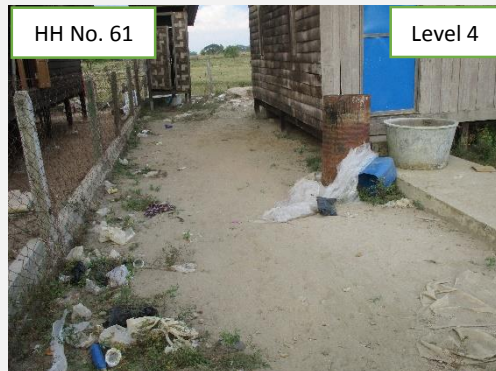
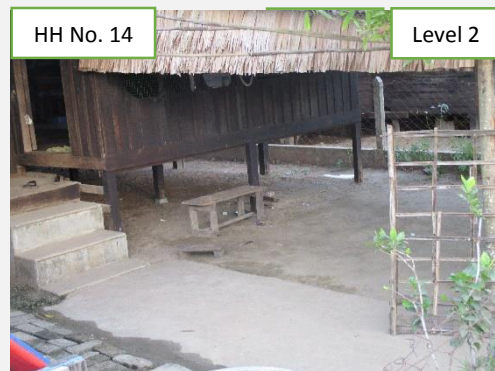
4	Other issue	Description																	
	(1). Drainage condition for rain water in their compounds	<p><u>Description</u> -Rainy season has started. -Some of the compounds are wet.</p>

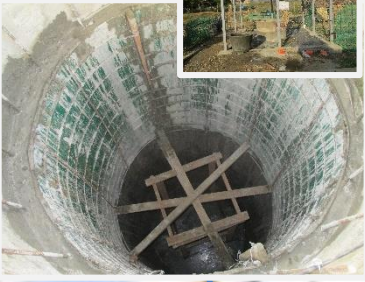
As water is dirty, bad smell and felt itch on skin, the well has been repairing since four days ago.

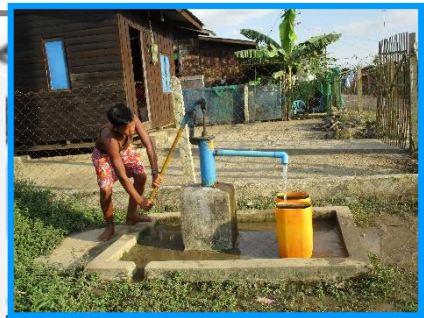
Hand pump isn't functioned.

As the buffer has been changed with the new one and the hand pump is functioned very well now. Water is also clean and people living nearby use it for drinking and living.

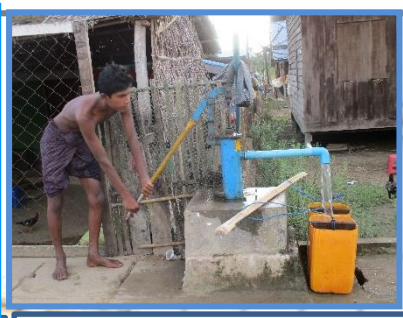
This hand pump is functioned very well. Water is clean and people nearby are using this hand pump for drinking and living.

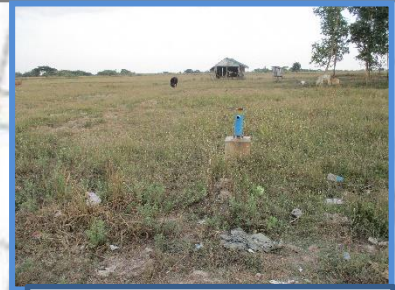
This well cannot be used as water is dirty and it has been repairing too.

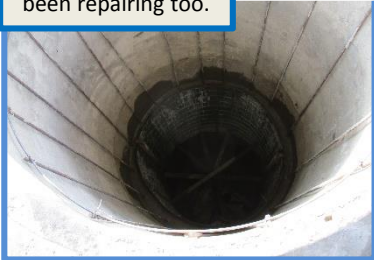
The buffer of the hand pump needs to be change. Therefore, people living nearby are using water from their owned pump at the moment.

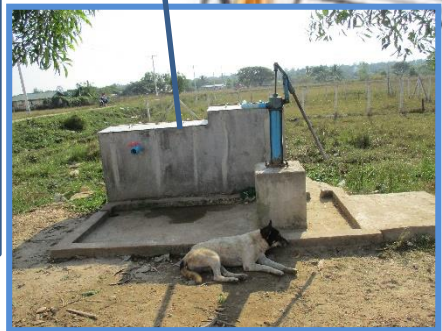
This hand pump is functioned very well. Water is clean and people living nearby are using this hand pump. Moreover water filter tank for removing the smell of iron has been set up beside the hand pump. There is no smell of iron and people enjoy water for drinking and living use.
