Surveyor: Zaw La

Date Visited: 23.10.2015

No	Item	Condition	Description and Photos
1	Condition of -		
	(1). Well	Improved <input type="checkbox"/> Same <input type="checkbox"/> Worse <input checked="" type="checkbox"/> * <i>*as last week</i>	Description & Photos: -See ANNEX.1 - Although both of the two open wells are dirty, it seems that muddy water under the ground is passing through the crack at the wall of the well. Compared with last week, both wells cannot be used and therefore people use hand pumps, or rain water at the moment. In terms of avoiding the muddy groundwater passing to the well, both open wells need to be renovated again in summer. The buffers of some hand pumps need to be changed, but people get water from their own well or rain water currently.

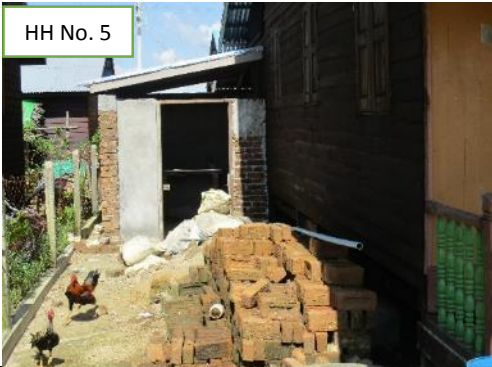
No	Item	Condition	Description and Photos
2	House Construction	No. of houses not completed (2)	<p><u>Description</u> -HH No.5, the construction for kitchen, toilet and water tank seems to be stopped again.</p>

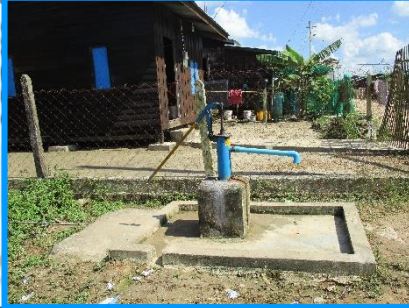
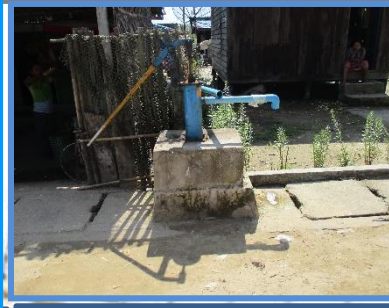
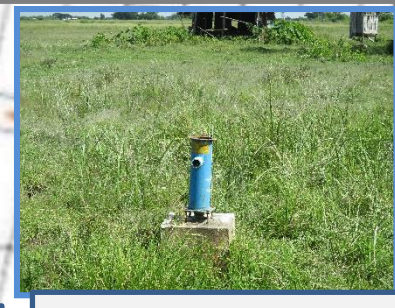
Water seems to be clean and people nearby are using it for drinking and living use for some months ago. But some people who took bath from this well said they felt itch on their skin. Therefore, U Ba Than, one of PAs, absorbed water by motor and he saw that water in the deepest area was very dirty with bad smell. The well also needs to be repaired as soon as possible.

As the buffer has been changed with the new one and the hand pump is functioned very well now. Water is also clean and people living nearby use it for drinking and living use again.

This hand pump is functioned very well. Water is clean and people nearby are using this hand pump for drinking and living use.

Hand pump isn't functioned.

This well cannot be used as water is dirty. A pulley wheel, bucket and a rope have been set up but the rope seems to be thin and it is better to be changed with a thick one for the better use.

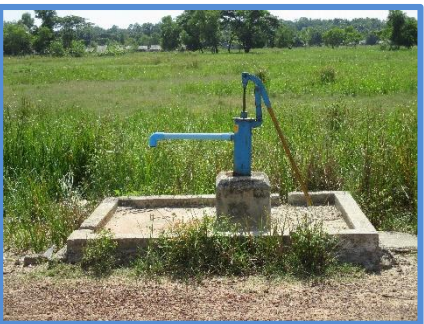
The buffer of the hand pump needs to be change. Therefore, people living nearby are using water from their owned pump or rain water at the moment.

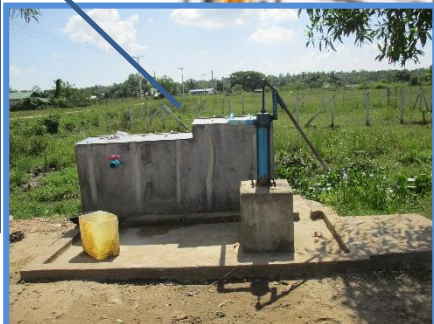
This hand pump is functioned very well. Water is clean and people living nearby are using this hand pump. Moreover water filter tank for remove the smell of iron has been set up beside the hand pump. There is no smell of iron and people enjoy water for drinking and living use.
