Weekly Field Report

No. 6

Date Visited: 24.9.2014

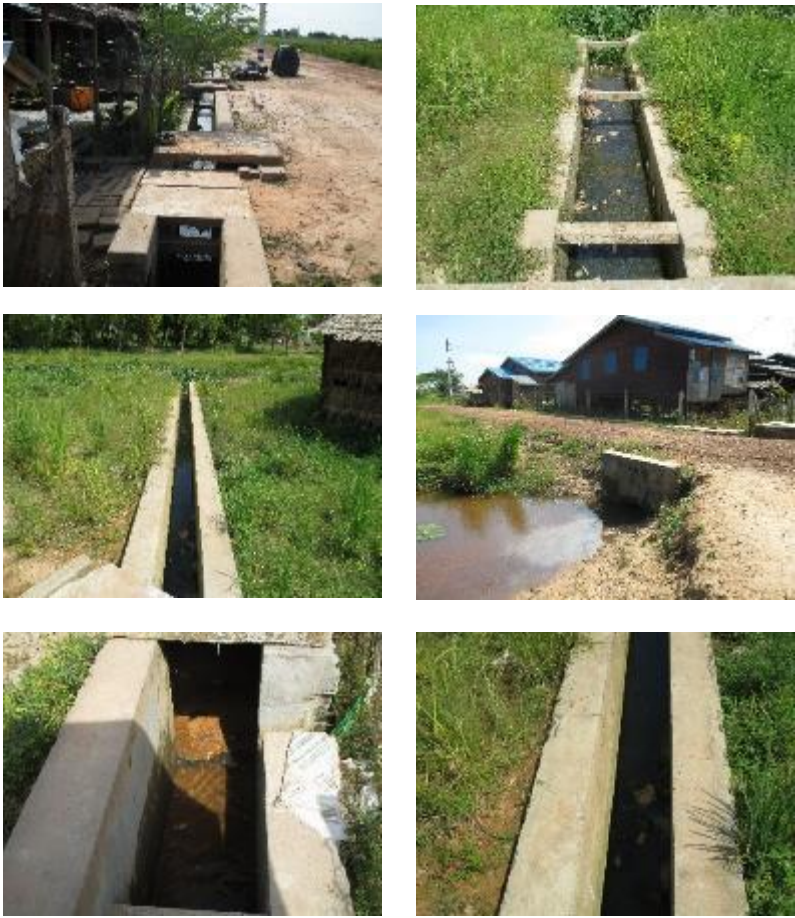
No	Item	Condition	Description and Photos
1	Condition of -		
	(1). Well	Improved <input type="checkbox"/> Same <input checked="" type="checkbox"/> * Worse <input type="checkbox"/> <i>*as last week</i>	Description & Photos: -See ANNEX.1 -Hand Pumps of Well No.6 and 11 are needed to repair.
	(2). Drainage	Improved <input type="checkbox"/> Same <input checked="" type="checkbox"/> Worse <input type="checkbox"/> <i>*as last week</i>	<u>Description</u> -Water level in the drainage canal is near to the bottom. <u>Photos</u>

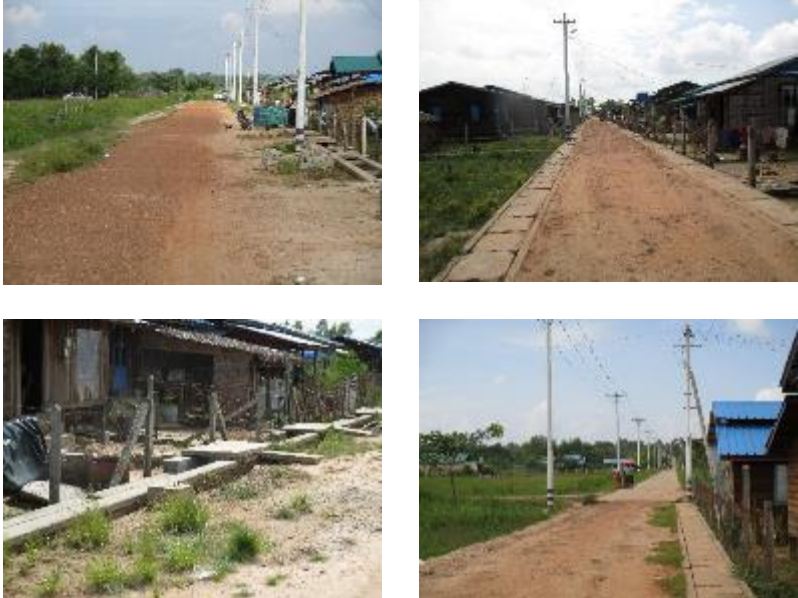
(3). Road	Improved <input type="checkbox"/> Same <input checked="" type="checkbox"/> * Worse <input type="checkbox"/> <i>*as last week</i>	<u>Description</u> -The roads are almost dry and no problem for traffic as a whole.

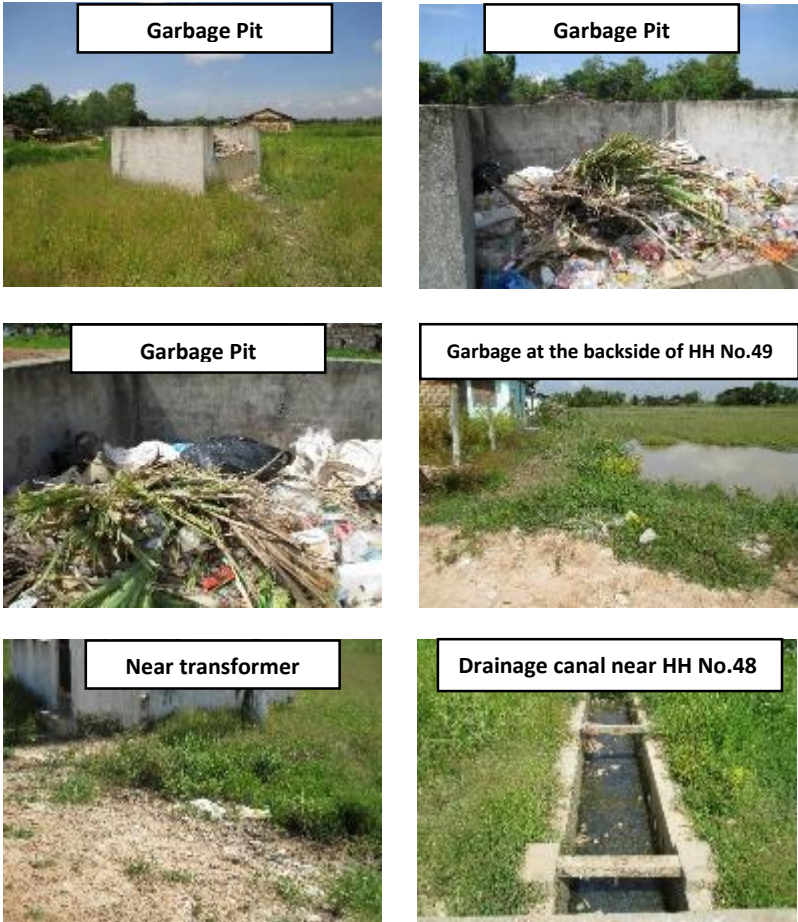
<p>(4). Garbage Condition</p>	<p>Improved <input checked="" type="checkbox"/> Same <input type="checkbox"/> Worse <input type="checkbox"/></p>	<p><u>Description</u></p> <ul style="list-style-type: none"> -Garbage pit is used by people. -Smells are emerging from garbage pit. -Garbage pit is nearly full.

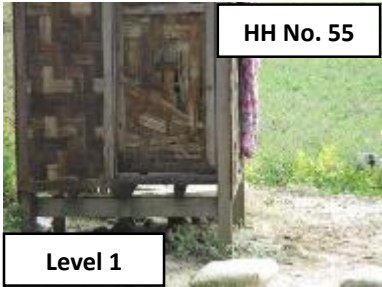
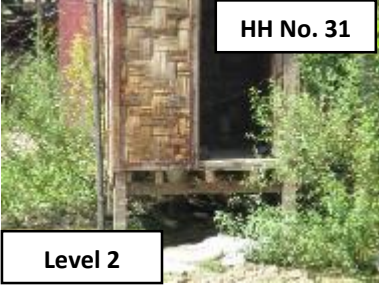
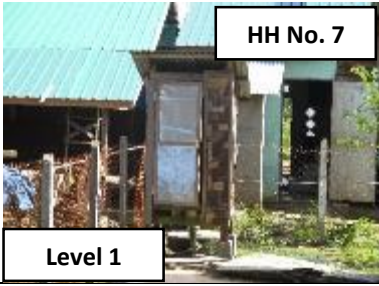
No	Item	Condition	Description and Photos																				
1	(5). Fly proof toilet	Improved <input type="checkbox"/> Same <input checked="" type="checkbox"/> Worse <input type="checkbox"/> <i>*as last week</i>	<p><u>Description</u> -All of fly proof toilets are being used by people.</p>

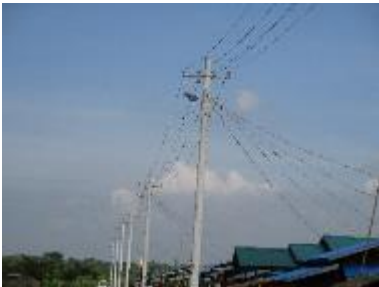
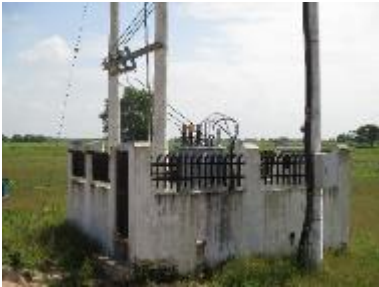
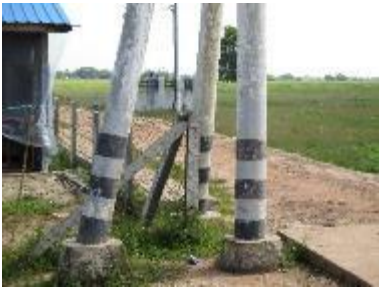
Condition	No. of HHs		This week condition	Previous week condition	Level 1	42	42	Level 2	21	21	Level 3	0	0	Level 4	0	0	No Toilet	5	5
Condition	No. of HHs																						
	This week condition	Previous week condition																					
Level 1	42	42																					
Level 2	21	21																					
Level 3	0	0																					
Level 4	0	0																					
No Toilet	5	5																					
	(6). Electricity	Improved <input type="checkbox"/> Same <input checked="" type="checkbox"/> Worse <input type="checkbox"/> <i>*as last week</i>	<p><u>Description</u> -Electricity is coming regularly -Electric poles and transformer are supported in good foundation.</p> <p><u>Photos</u></p>

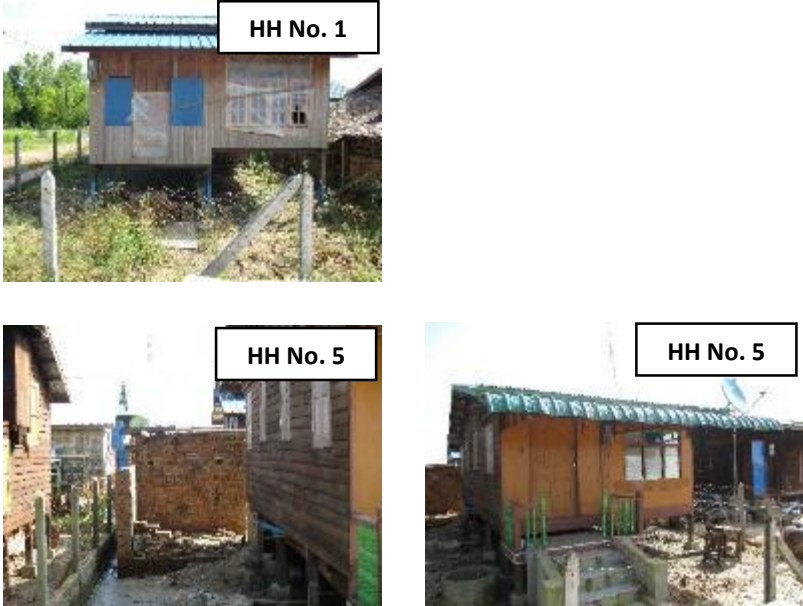
No	Item	Condition	Description and Photos																	
2	House Construction	No. of houses not completed (2)	<p><u>Description</u></p> <p>-HH No.1 doesn't have ladder and nobody is living -In HH No.5, the construction for kitchen, toilet and water tank seems stopped. Nobody lives. -In HH No.5, sun shade of this house has been repaired.</p> <p><u>Photos</u></p>

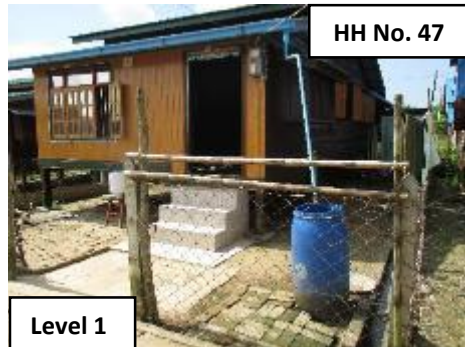
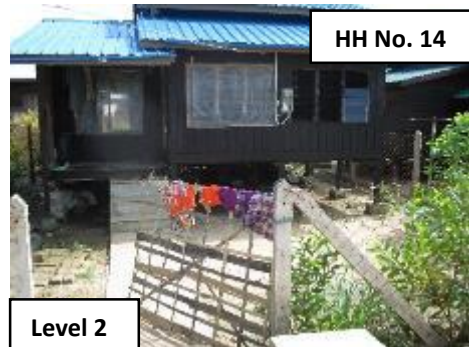
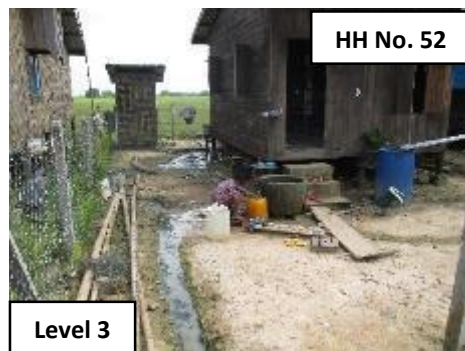
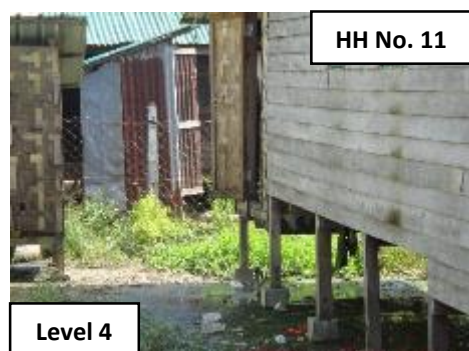
3	Living Status of PAPs (Sold house, renting, etc.)	<p><u>Description</u></p> <p>(1) House ownership (1)-1 No. of house that are owned by PAPs (49) (1)-2 No. of house that were sold (19)</p> <p>(2) Living condition (2)-1 No. of houses where PAPs live (37) (2)-2 No. of houses where not original PAPs lives (26) (2)-3 No. of houses where nobody lives (5)</p> <p>Yellow= Changes from previous week</p>	<p>Location Map: See ANNEX.2</p>																	
4	Other issues		<p>(1). Drainage condition for rain water in their compounds</p> <p><u>Description</u></p> <p>-In most of the compounds, they become dry because of less rains.</p>

-No mud and no standing water in their compound
Level 3
 - Some or little mud and standing water in their compound
Level 4
 -A lot of mud and standing water in their compound

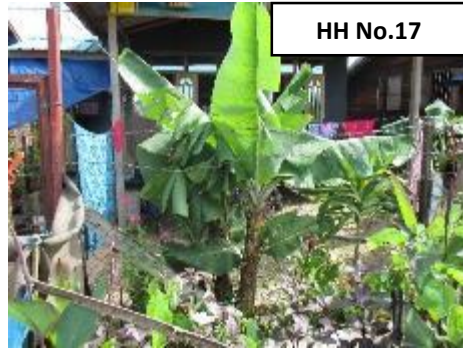
HH No.17

Type	No. of HHs	Remarks
Shady tree	12	Albizzia, Indian almond, etc. HH No. 2, 3, 14, 19, 20, 21, 25, 27, 29, 32, 41 and 65
Fruit tree	24	Banana, Mango, sugarcane, coconut, citrus, etc. HH No. 2, 3, 4, 7, 8, 9, 11, 17, 21,24, 25, 27, 33, 37, 38, 39, 41, 43, 45, 46, 47, 48, 54 and 65
Vegetable	10	Spices, peas, roselle, etc. HH No. 22, 23, 25, 27, 38, 39, 40, 42,45 and 63
Floral plant	20	Many species. HH No. 2, 9, 14, 15, 17,21, 23, 27, 32, 33, 38, 39, 40, 41, 42, 43, 47, 48, 58 and 65

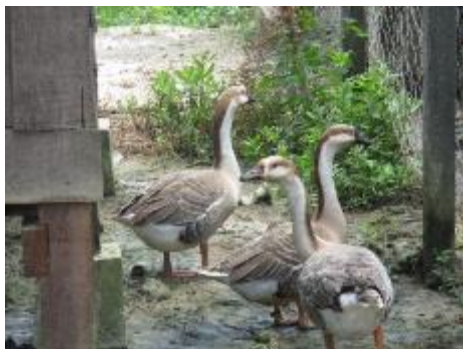
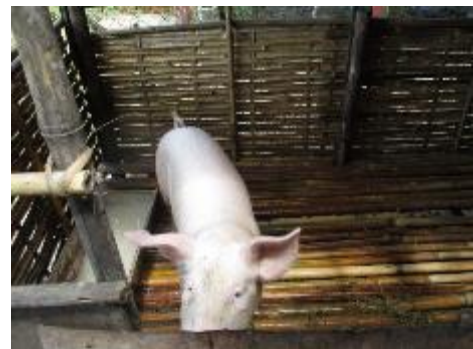
-They are raising chicken, ducks, goats, pigs and cows.
 -Even though they have cows, they do not keep their cows in relocation site instead they keep in their farms or other places.

Type	No. of HHs	Remarks
Cow	5	HH No. 3, 18, 42, 47 and 54
Pig	1	HH No. 2
Goat	2	HH No. 50 and 51
Chicken and ducks	15	HH No. 4, 8, 12, 14, 28, 30, 32, 41, 47, 50, 51, 52, 55, 56 and 62

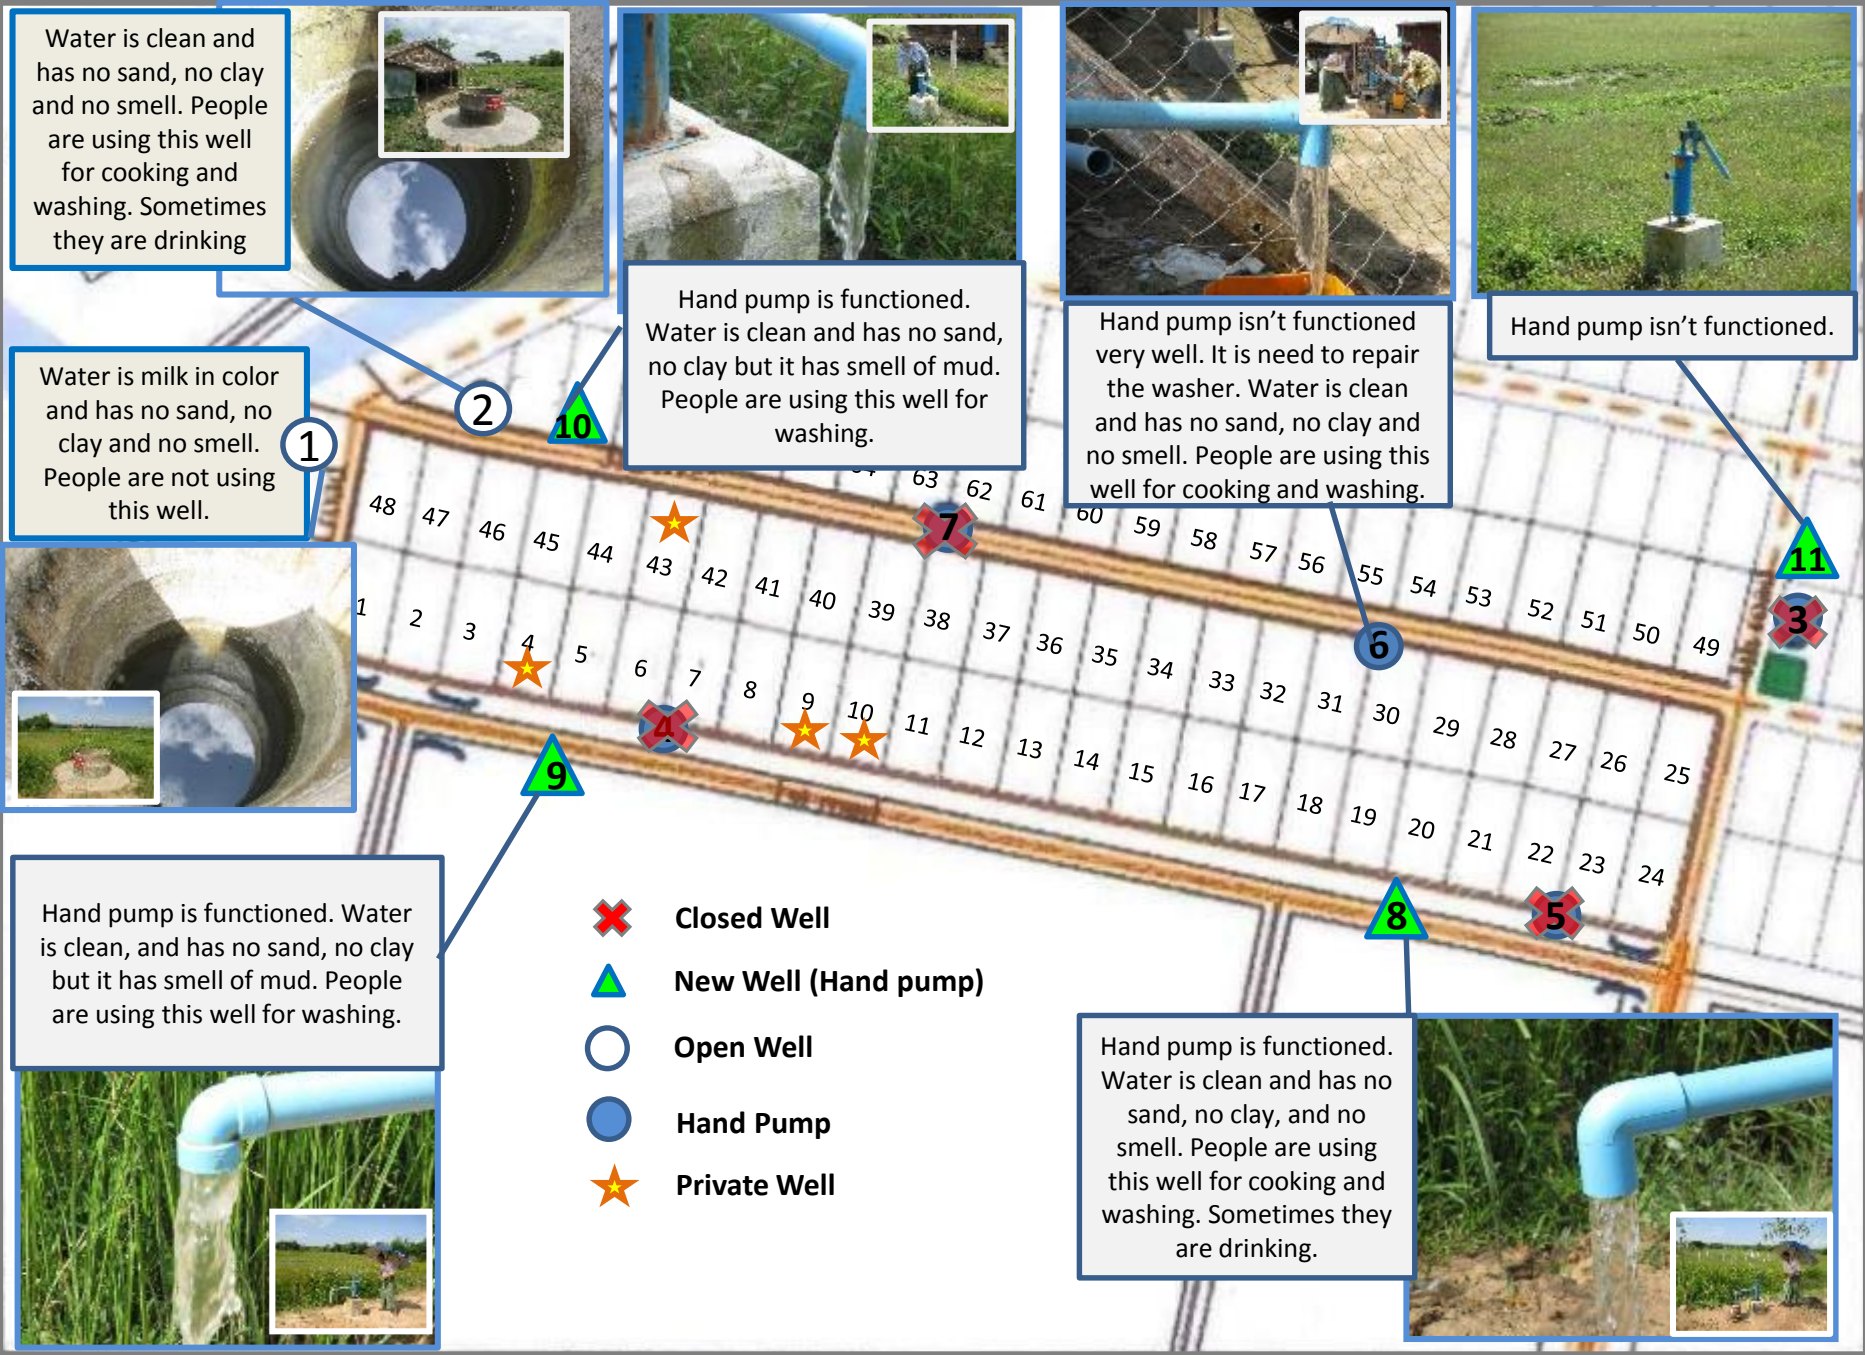
Water is clean and has no sand, no clay and no smell. People are using this well for cooking and washing. Sometimes they are drinking

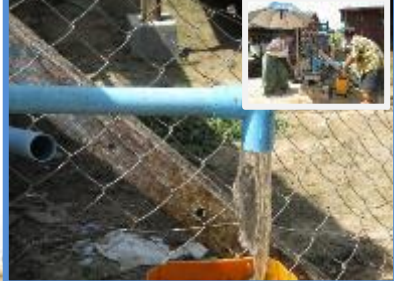
Hand pump is functioned. Water is clean and has no sand, no clay but it has smell of mud. People are using this well for washing.

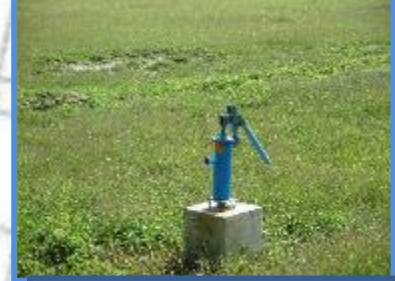
Hand pump isn't functioned very well. It is need to repair the washer. Water is clean and has no sand, no clay and no smell. People are using this well for cooking and washing.

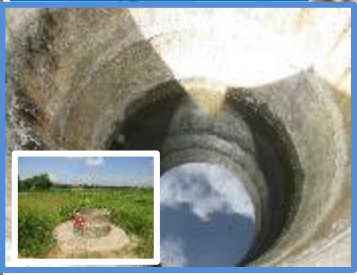
Hand pump isn't functioned.

Water is milk in color and has no sand, no clay and no smell. People are not using this well.

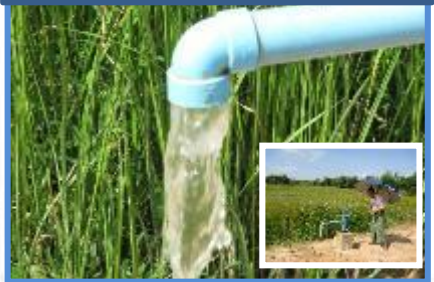
Hand pump is functioned. Water is clean, and has no sand, no clay but it has smell of mud. People are using this well for washing.

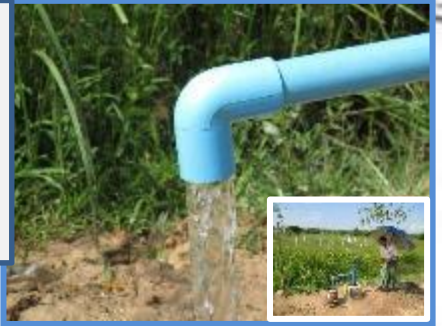
Hand pump is functioned. Water is clean and has no sand, no clay, and no smell. People are using this well for cooking and washing. Sometimes they are drinking.
