Weekly Field Report

No. 8

Date Visited: 07.10.2014

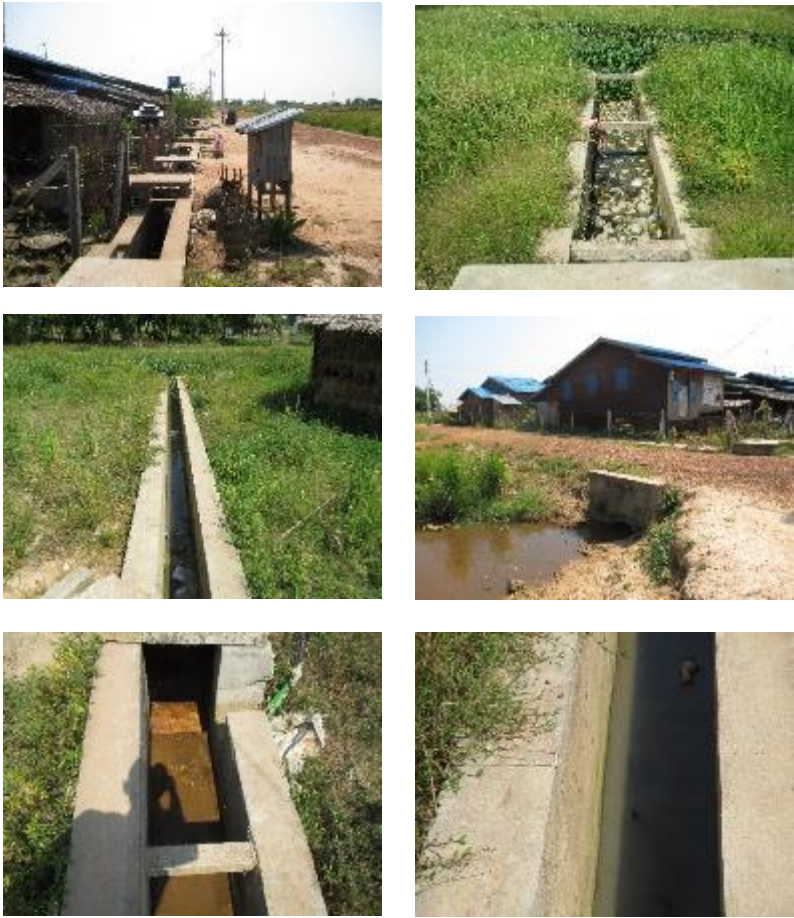
No	Item	Condition	Description and Photos
1	Condition of -		
	(1). Well	Improved <input type="checkbox"/> Same <input checked="" type="checkbox"/> * Worse <input type="checkbox"/> <i>*as last week</i>	Description & Photos: -See ANNEX.1 -Hand Pumps of Well No.6 and 11 are needed to repair.
	(2). Drainage	Improved <input type="checkbox"/> Same <input checked="" type="checkbox"/> Worse <input type="checkbox"/> <i>*as last week</i>	<p><u>Description</u> -Water level in the drainage canal is near to the bottom.</p> <p><u>Photos</u></p>

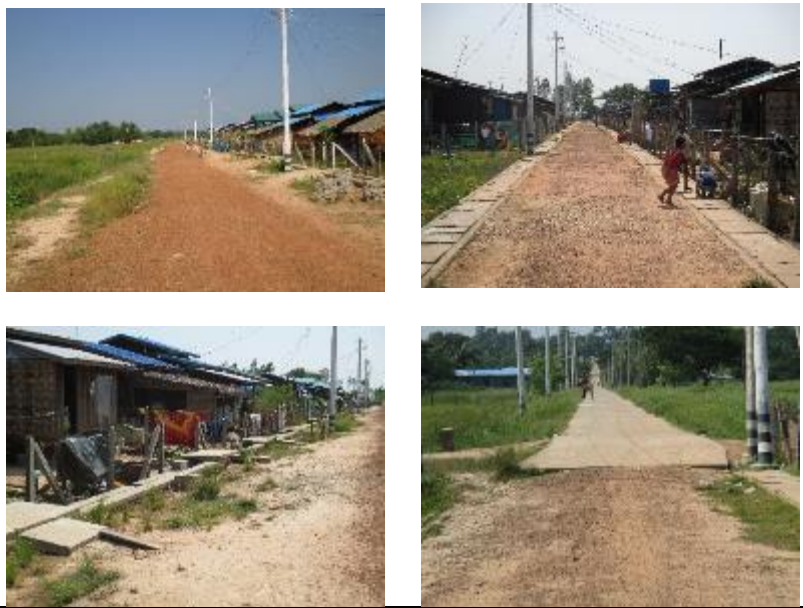
(3). Road	Improved <input type="checkbox"/> Same <input checked="" type="checkbox"/> * Worse <input type="checkbox"/> <i>*as last week</i>	<p><u>Description</u> -The roads are almost dry and no problem for traffic as a whole.</p>

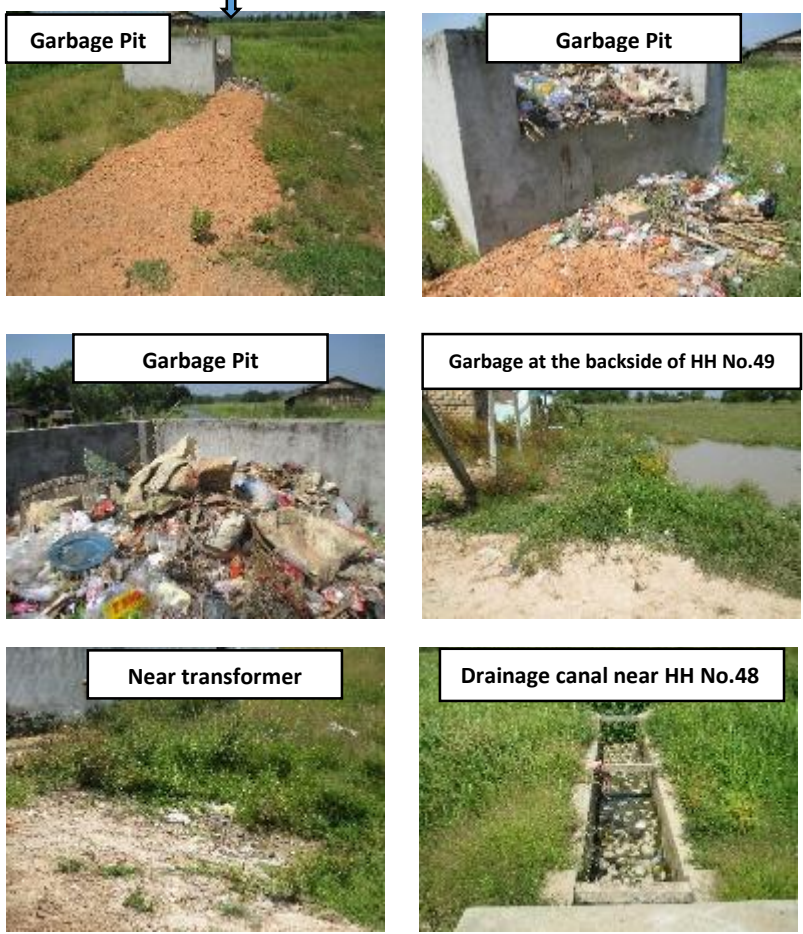
(4). Garbage Condition	<p>Improved <input type="checkbox"/></p> <p>Same <input checked="" type="checkbox"/></p> <p>Worse <input type="checkbox"/></p>	<p><u>Description</u></p> <ul style="list-style-type: none"> -Garbage pit is used by people. -Smells are emerging from garbage pit. -Garbage pit is full. -Small path between the garbage pit and road No.2 is renovated by putting soil on last Sunday 5th Oct, 2014 by village tract administrator. (see photo below)

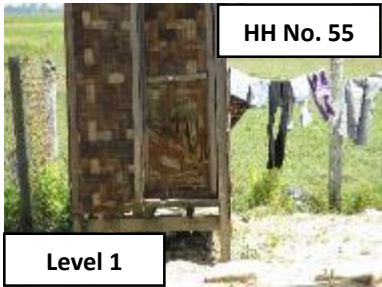
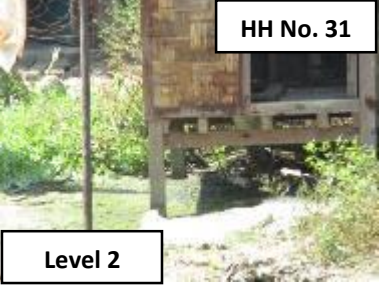
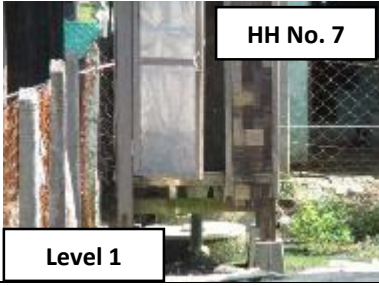
No	Item	Condition	Description and Photos																				
1	(5). Fly proof toilet	Improved <input type="checkbox"/> Same <input checked="" type="checkbox"/> Worse <input type="checkbox"/> <i>*as last week</i>	<p><u>Description</u> -All of fly proof toilets are being used by people.</p>

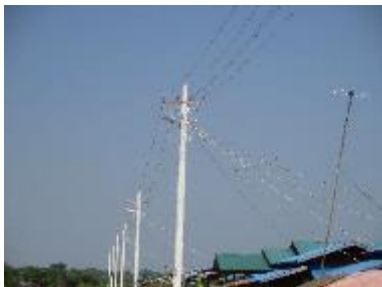
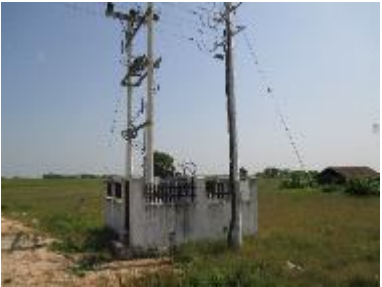
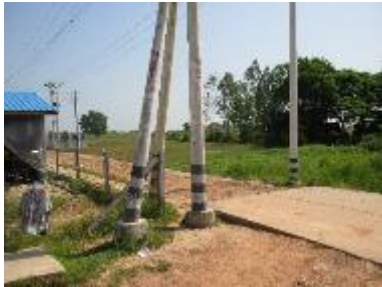
Condition	No. of HHs		This week condition	Previous week condition	Level 1	42	42	Level 2	21	21	Level 3	0	0	Level 4	0	0	No Toilet	5	5
Condition	No. of HHs																						
	This week condition	Previous week condition																					
Level 1	42	42																					
Level 2	21	21																					
Level 3	0	0																					
Level 4	0	0																					
No Toilet	5	5																					
	(6). Electricity	Improved <input type="checkbox"/> Same <input checked="" type="checkbox"/> [*] Worse <input type="checkbox"/> <i>*as last week</i>	<p><u>Description</u> -Electricity is coming regularly -Electric poles and transformer are supported in good foundation.</p> <p><u>Photos</u></p>

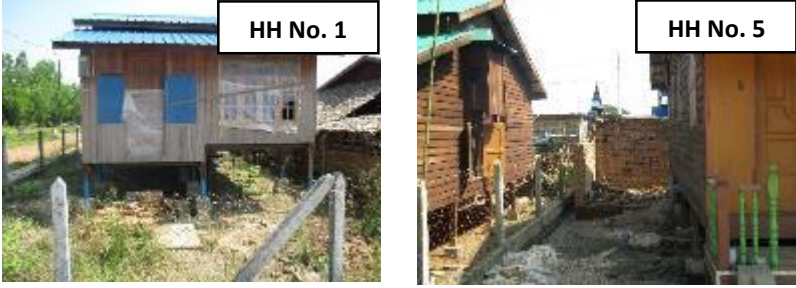
No	Item	Condition	Description and Photos																	
2	House Construction	No. of houses not completed (2)	<p><u>Description</u> -HH No.1 doesn't have ladder and nobody is living -In HH No.5, the construction for kitchen, toilet and water tank seems stopped. Nobody lives.</p> <p><u>Photos</u></p>

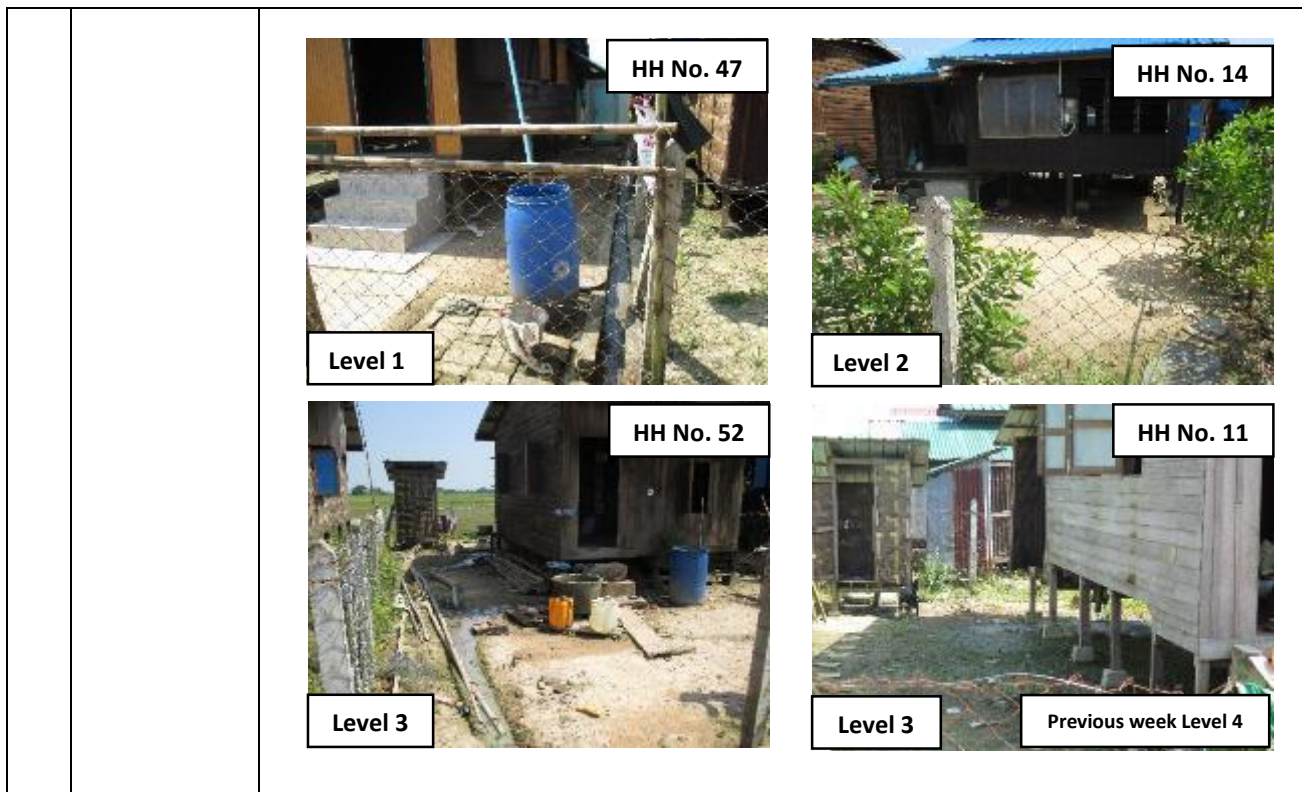
3	Living Status of PAPs (Sold house, renting, etc.)	<p><u>Description</u> (1) House ownership (1)-1 No. of house that are owned by PAPs (49) (1)-2 No. of house that were sold (19) (2) Living condition (2)-1 No. of houses where PAPs live (37) (2)-2 No. of houses where not original PAPs lives (26) (2)-3 No. of houses where nobody lives (5)</p>	<p>Location Map: See ANNEX.2</p>																	
4	Other issues		<p>(1). Drainage condition for rain water in their compounds</p> <p><u>Description</u> -In most of the compounds, they become dry because of less rain.</p>

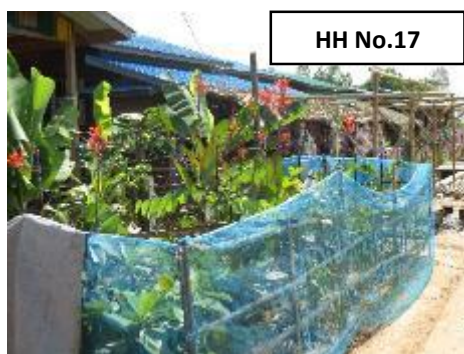
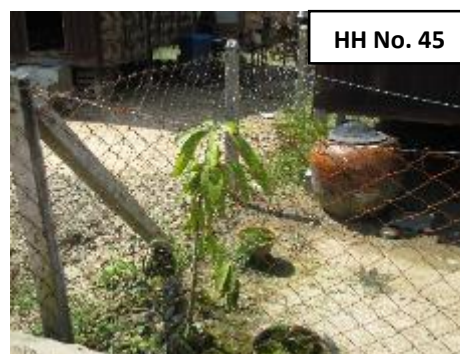
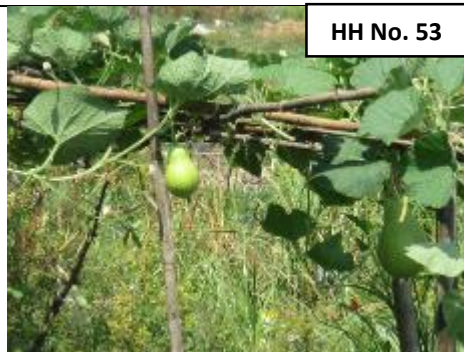
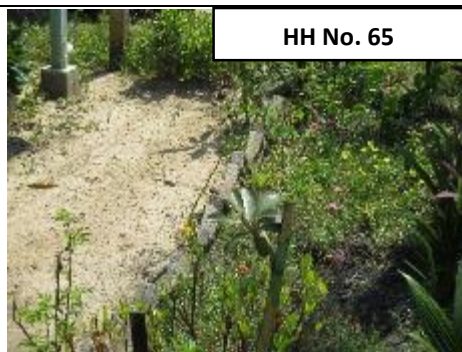
Photos

Type	No. of HHs	Remarks
Shady tree	12	Albizia, Indian almond, etc. HH No. 2, 3, 14, 19, 20, 21, 25, 27, 29, 32, 41 and 65
Fruit tree	24	Banana, Mango, sugarcane, coconut, citrus, etc. HH No. 2, 3, 4, 7, 8, 9, 11, 17, 21,24, 25, 27, 33, 37, 38, 39, 41, 43, 45, 46, 47, 48, 54 and 65
Vegetable	10	Spices, peas, roselle, etc. HH No. 22, 23, 25, 27, 38, 39, 40, 42,45 and 63
Floral plant	20	Many species. HH No. 2, 9, 14, 15, 17,21, 23, 27, 32, 33, 38, 39, 40, 41, 42, 43, 47, 48, 58 and 65

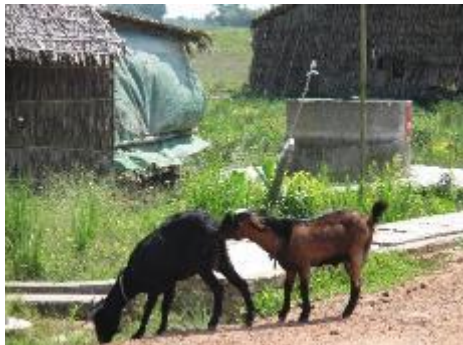
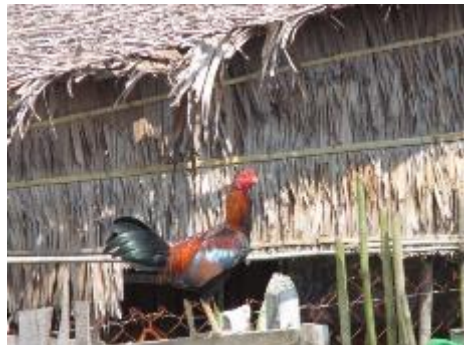
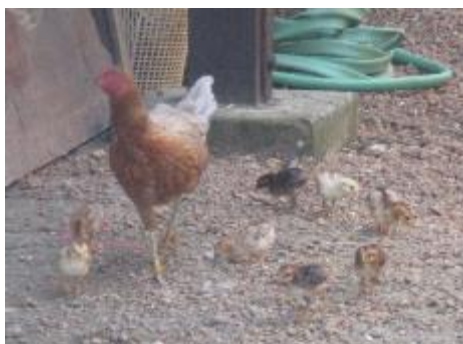
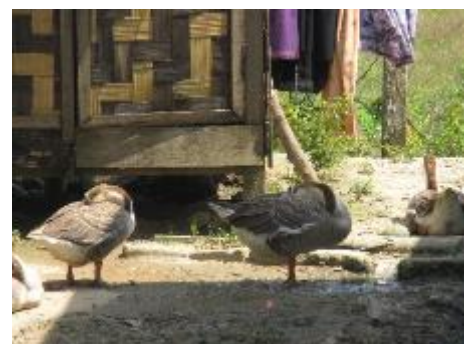
Photos

-They are raising chicken, ducks, goats, pigs and cows.
 -Even though they have cows, they do not keep their cows in relocation site instead they keep in their farms or other places.

Type	No. of HHs	Remarks
Cow	5	HH No. 3, 18, 42, 47 and 54
Pig	1	HH No. 2
Goat	2	HH No. 50 and 51
Chicken and ducks	15	HH No. 4, 8, 12, 14, 28, 30, 32, 41, 47, 50, 51, 52, 55, 56 and 62

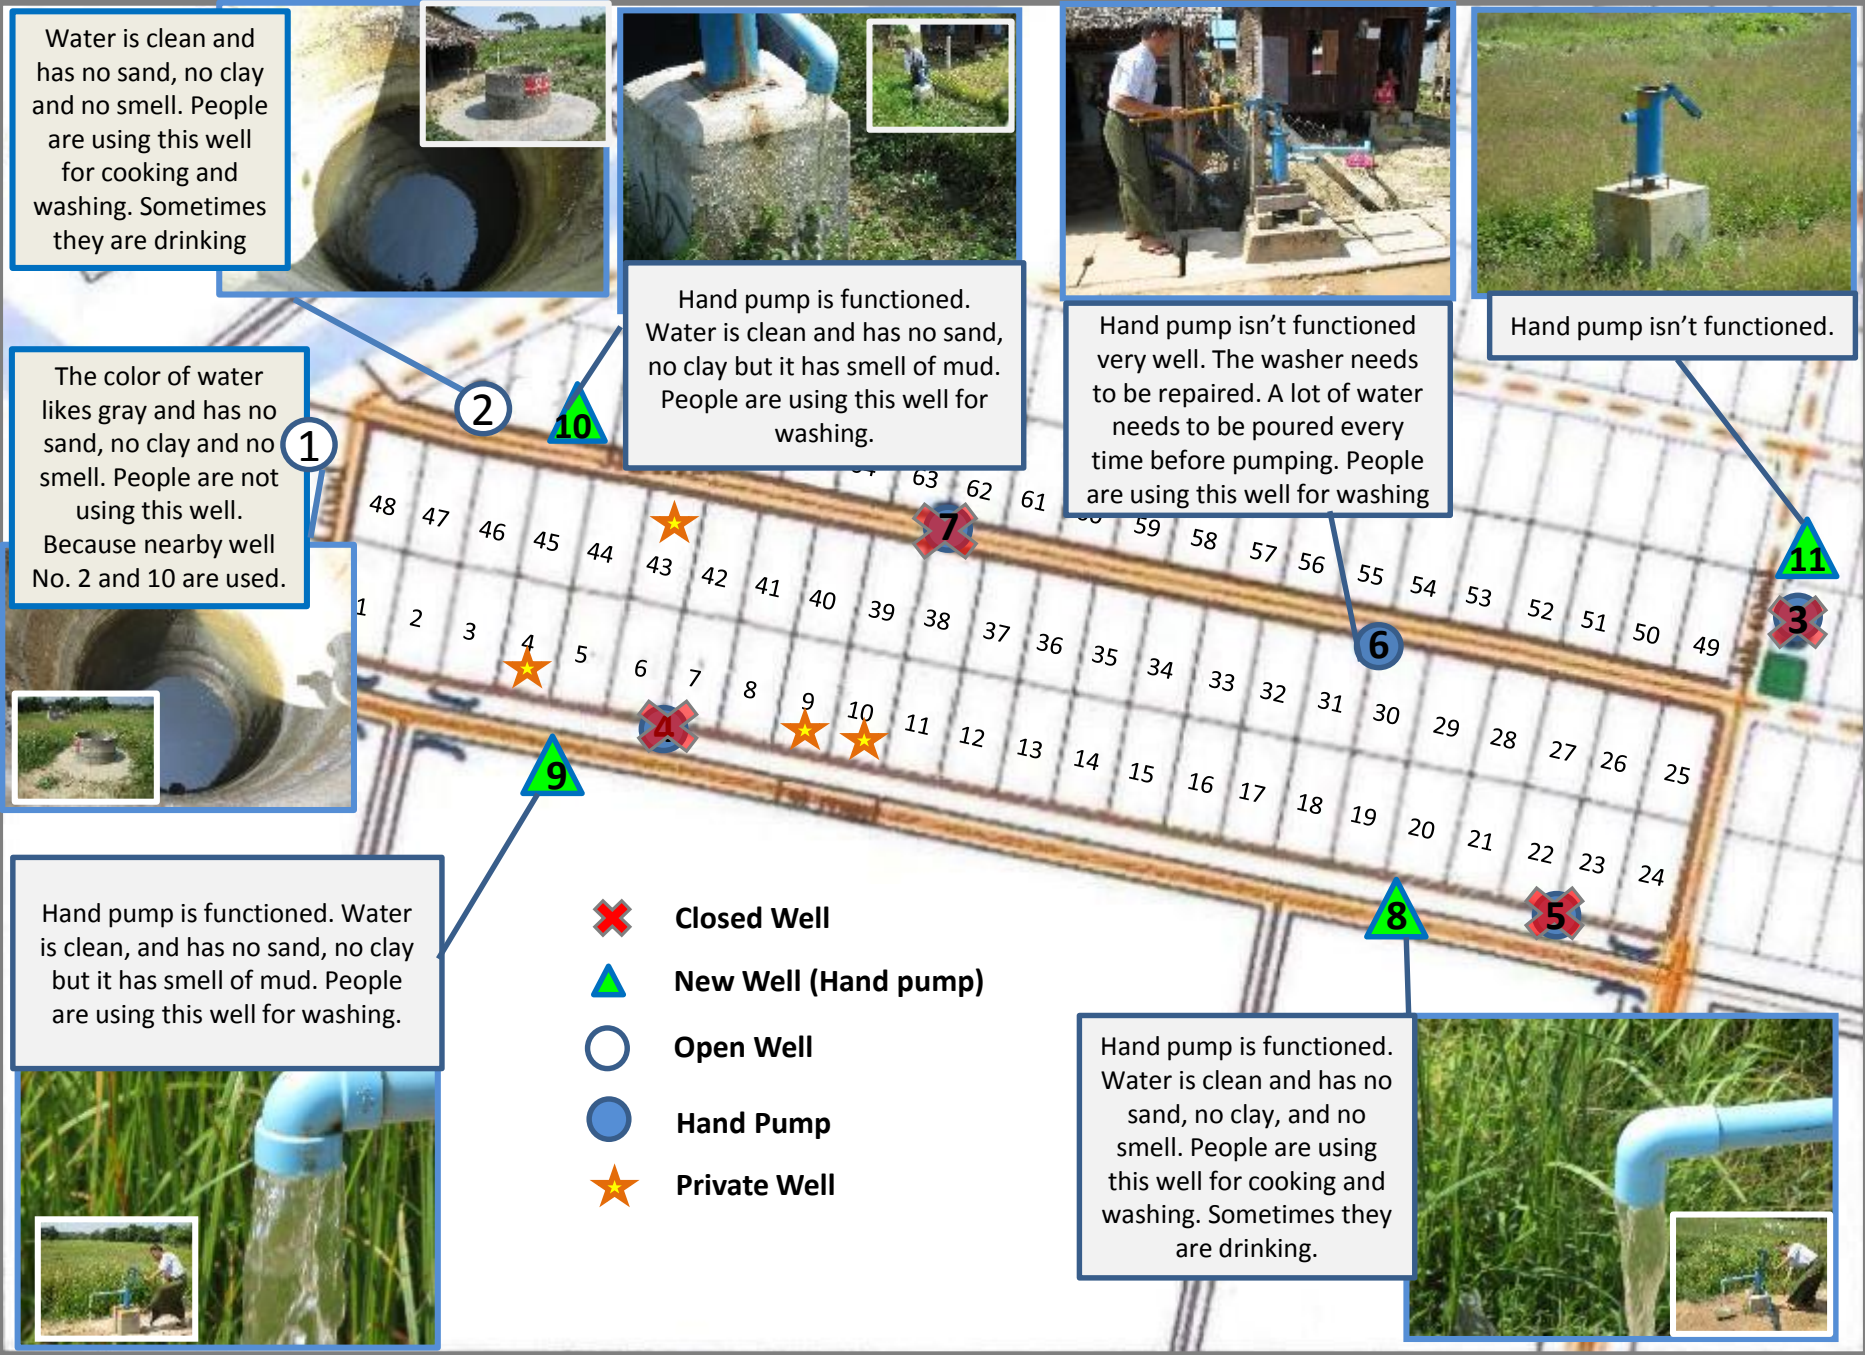
Water is clean and has no sand, no clay and no smell. People are using this well for cooking and washing. Sometimes they are drinking

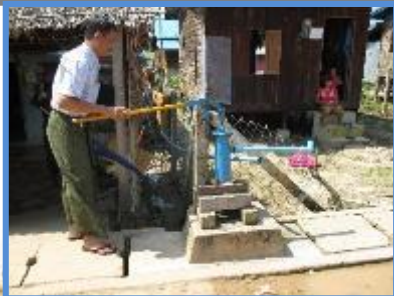
Hand pump is functioned. Water is clean and has no sand, no clay but it has smell of mud. People are using this well for washing.

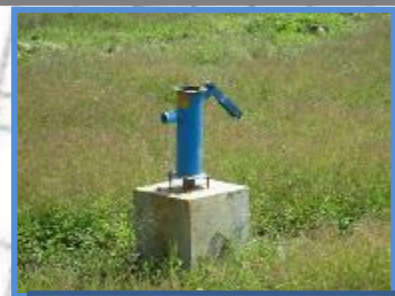
Hand pump isn't functioned very well. The washer needs to be repaired. A lot of water needs to be poured every time before pumping. People are using this well for washing

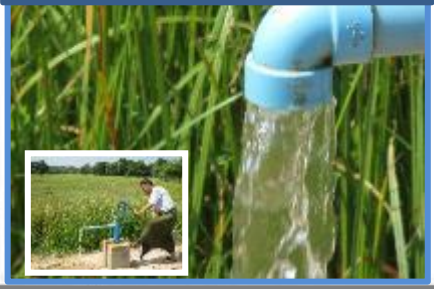
Hand pump is functioned. Water is clean, and has no sand, no clay but it has smell of mud. People are using this well for washing.

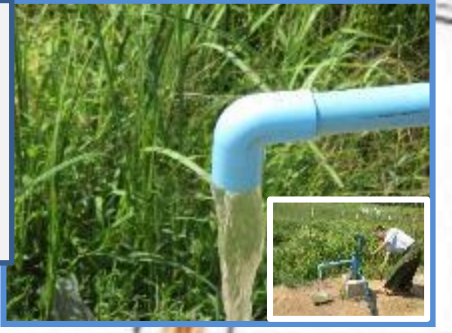
Hand pump is functioned. Water is clean and has no sand, no clay, and no smell. People are using this well for cooking and washing. Sometimes they are drinking.
